**ARCADIA**

**ACCIDENT INVESTIGATION REPORT**

**ACCIDENTAL FAILURE OF LIFE BOAT No.5 LIFTING HOOK DURING  
RECOVERY**

**BERMUDA SHIPPING AND MARITIME AUTHORITY**

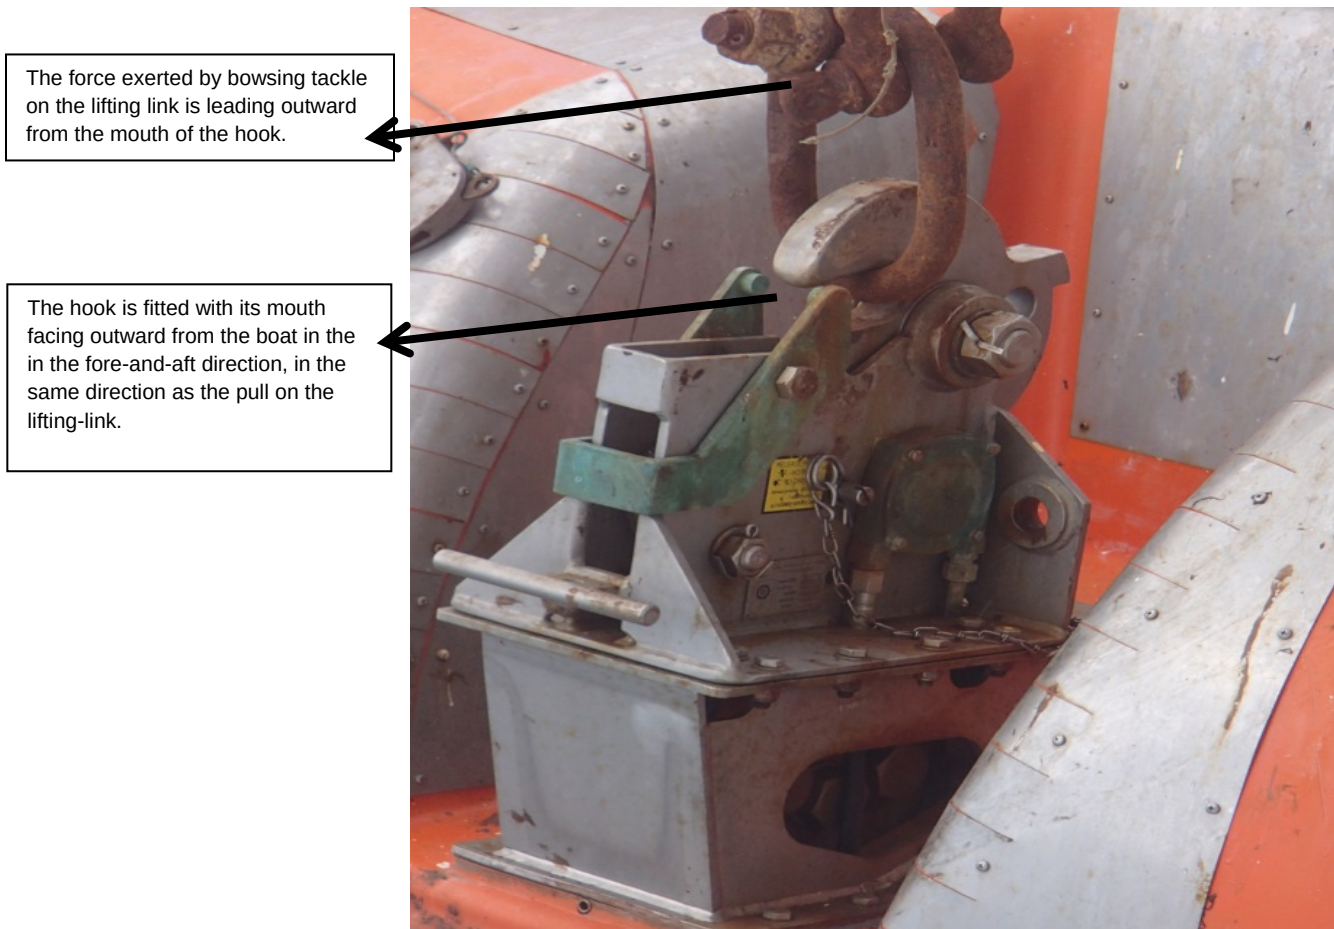
Figure 2: Representative Image of a Lifeboat Hook on ARCADIA

On Lifeboat No.5 the hooks are fitted with their mouths facing outwards. Due to the geometry of the hook and the fact that the hook opens in the same direction as the pull exerted by the bowsing tackle on the lifting-link. In the event of the failure of the stop-pawl or the arm of the stop pawl being bent away from the hook the mouth of the hook would be open and it would be easier for the lifting-link to exit from the hook when subjected to a pull leading outward.

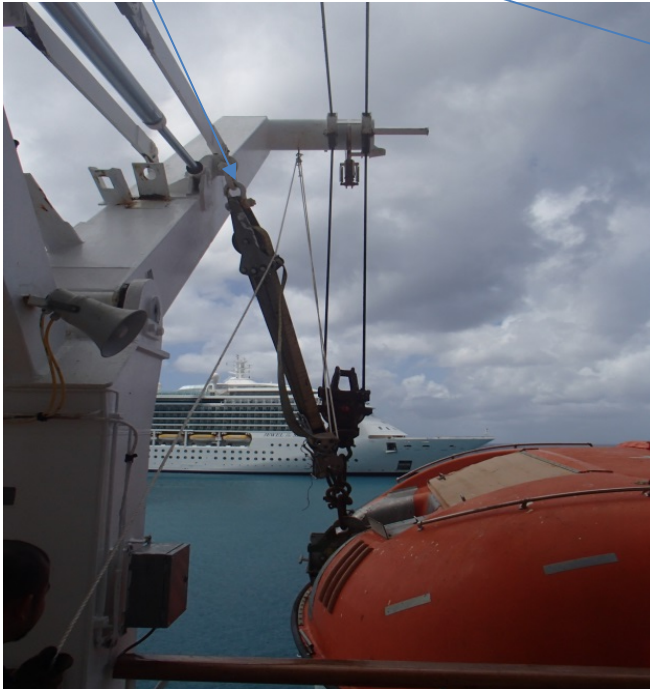
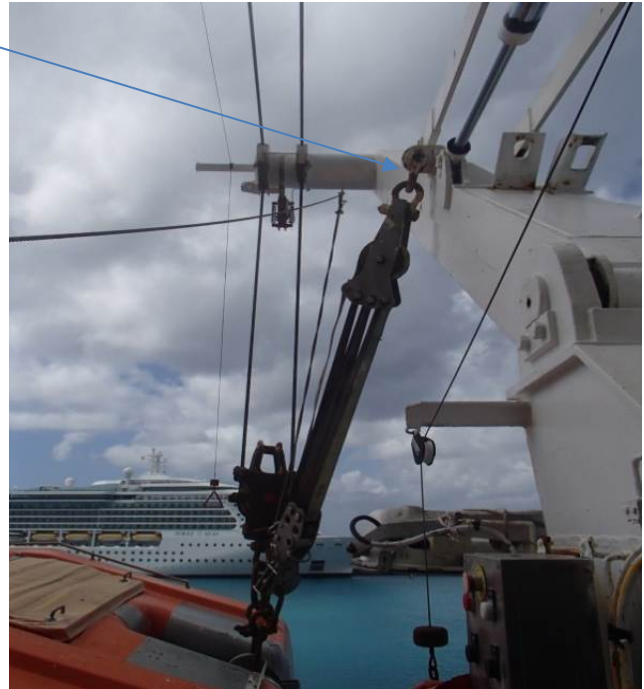
**Figure 3:** Forward Hook Assembly - Hook Mouth Facing Forward **Figure 4:** After Hook Assembly – Hook Mouth Facing Aft

The bowsing Tackles are connected to points high up on the davits meaning they lead away from the hook at an angle in the region of  $45^\circ$  from the vertical plane. This creates a twisting and pulling force on the lifting-link when the bowsing tackle takes load from the falls and tightens.

The angular moment created by the bowsing tackle induces a twist on the lifting link pulling the ring towards the mouth of the hook.

- iii) It is recommended that the company and hook manufacturer design and install an amended stop-pawl system.
- iv) It is recommended that the company, in consultation with the boat hook manufacturer, review the fitting arrangements for the bowsing tackle.

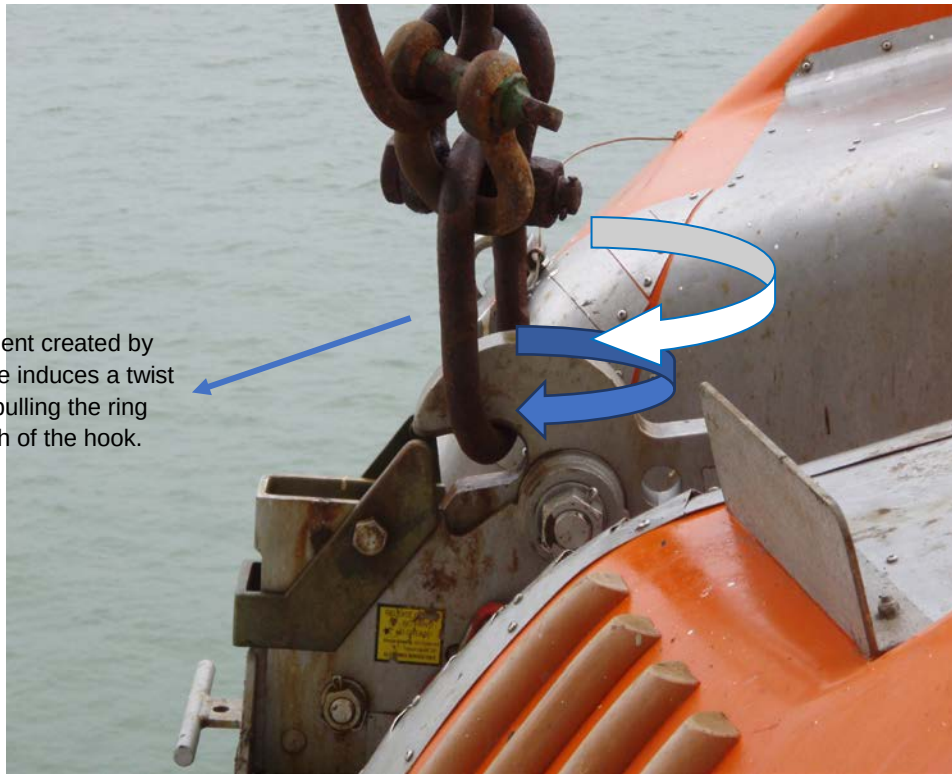
**Figure 5:** Depiction of Angular Moment Applied to Hook Assembly through the Bowsing Tackle

The recovery process was demonstrated a number of times in the presence of the investigator and it was noticed that the twisting moment varies depending upon the speed of descent of the boat. In some instances a pronounced jerk was witnessed as the various shackles within the system came under tension and aligned themselves.

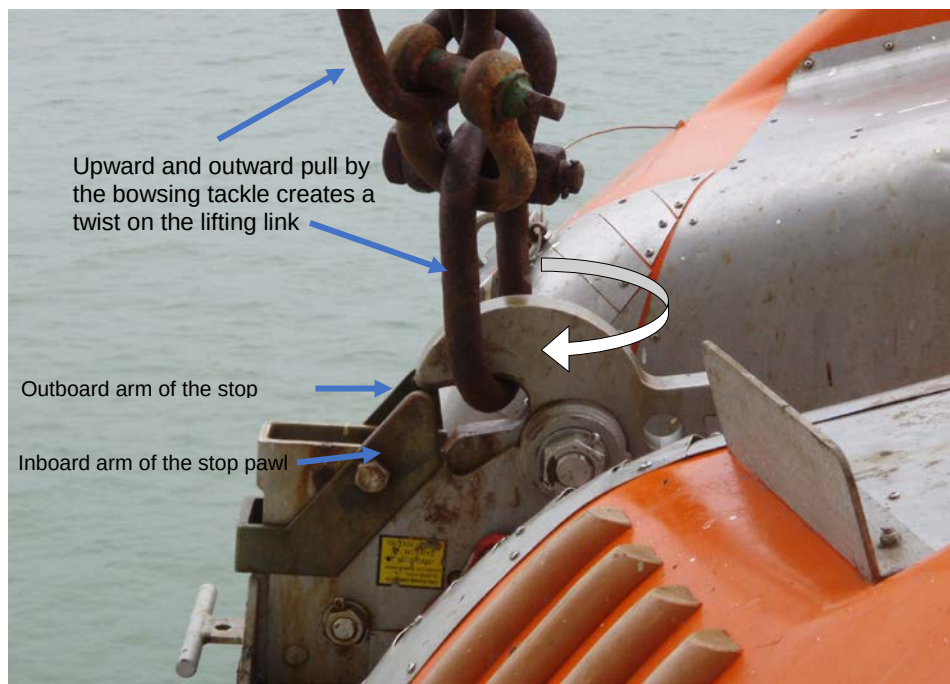
**Figure 6:** Forces on Lifeboat Hook During Recovery Process

The stop pawl is the safety device fitted to the hook assembly to prevent the lifting link coming out of the hook mouth. In the case of Lifeboat No.5 the inboard arm of the stop pawl of the forward hook was bent away from the hook which allowed the lifting-link to come free when pulled by the bowsing tackle.

- Twisting of the lifting-link around its vertical axis brings the inboard side of the lifting-link closer to the inboard arm of the stop pawl. This same action moves the outboard side of the link away from the outboard arm of the stop pawl
- As the bowing tackle continues to pull the lifting-link, the inboard side of the link lands against the inboard arm of the stop pawl
- Due to twisting, the outboard side of the lifting-link has moved away from the outboard arm of the stop pawl therefore the full twisting force transmitted to the lifting link acts on the inboard arm of the stop pawl alone
- The inboard arm of the stop pawl was not designed to resist force applied in this plane of movement and could not withstand the force exerted on it by the inboard side of the lifting-link so became deformed

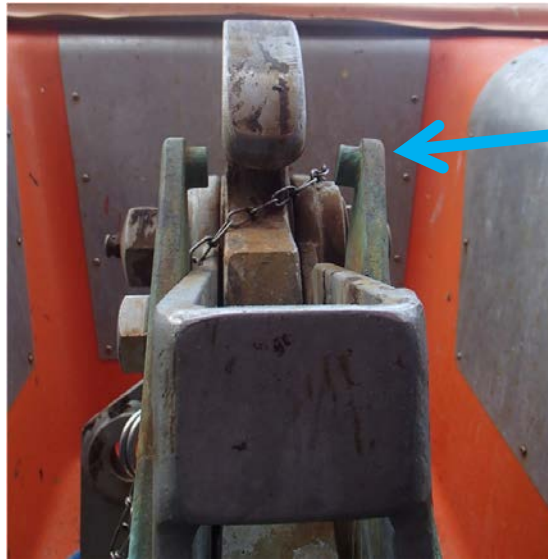
**Figure 7:** Forward Hook of Lifeboat No. 5 Following Recovery From the Sea – Note the bent arm

It should be noted that while the inboard arm of the stop pawl has been deformed on Lifeboat 5, there were other lifeboats where the stop pawl was observed to be deformed to a different extent, and this did not lead to an accident in these cases.

The inboard arm of the Stop-Pawl bent. The two arms of the stop-pawl are open ended and are susceptible to bending by a lateral force.

The stop pawl is the critical safety device fitted to the hook to prevent the lifting-link accidentally coming out of the mouth of the hook. The safety pawl of the forward hook of No. 5 lifeboat failed to do this because it was loaded in a manner for which it was not designed; by the attachment of the bowsing tackle to the lifting link.

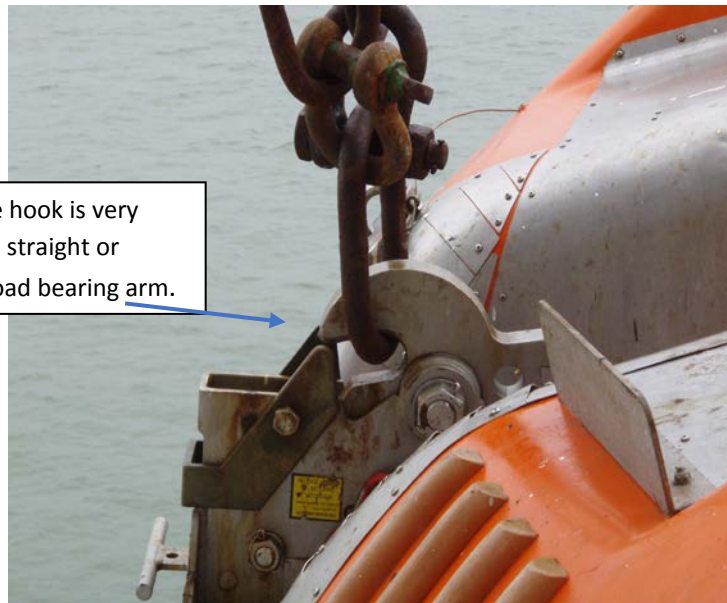
**Figure 8:** Image Showing Standard Lifeboat Hook Arrangement - Note the shallow hook shape

The shape of the hook is very shallow having a straight or nearly straight load bearing arm.

The load bearing part of the hook is very shallow and can be seen to be almost flat. The location of the stop pawl at the mouth of the hook is designed to negate the risk of the lifting link falling out of the hook as a result of this shallowness. However, if the inboard arm of the stop pawl were to become deformed - as happened in the case of Lifeboat No.5, the hook shape would increase the risk of the lifting link coming free. It is noted that the Lifeboats and Tenders onboard ARCADIA were re-hooked from the original Schat Harding hooks, to Fassmer Duplex E2 hooks in November 2013.

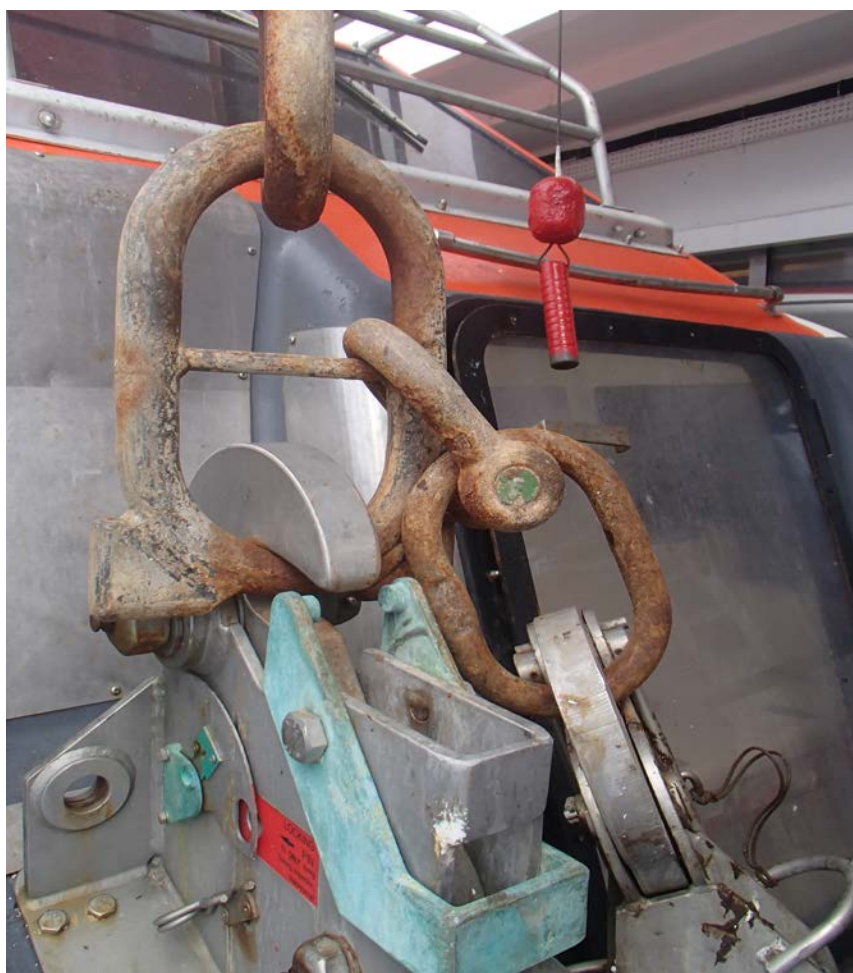
**Figure 9:** Image of a Tender Hook Arrangement. Note the lifting link centre stud and squaring at its base

It is noted that the link connecting the fall assembly to the boat hook is smaller than the size recommended by the hook manufacturer for use with this type of hook. Additionally, the links used on the lifeboats differ to the ones used on the tenders in that they do not have either a centre stud (cross bar) or the squaring of the link at the base.

- ii) The current lifting links on the ARCADIA lifeboats and other similar vessels in the CUK fleet are replaced with links meeting the hook manufacturer's recommended dimensions and of a similar design to the ones used on the ship's tenders.

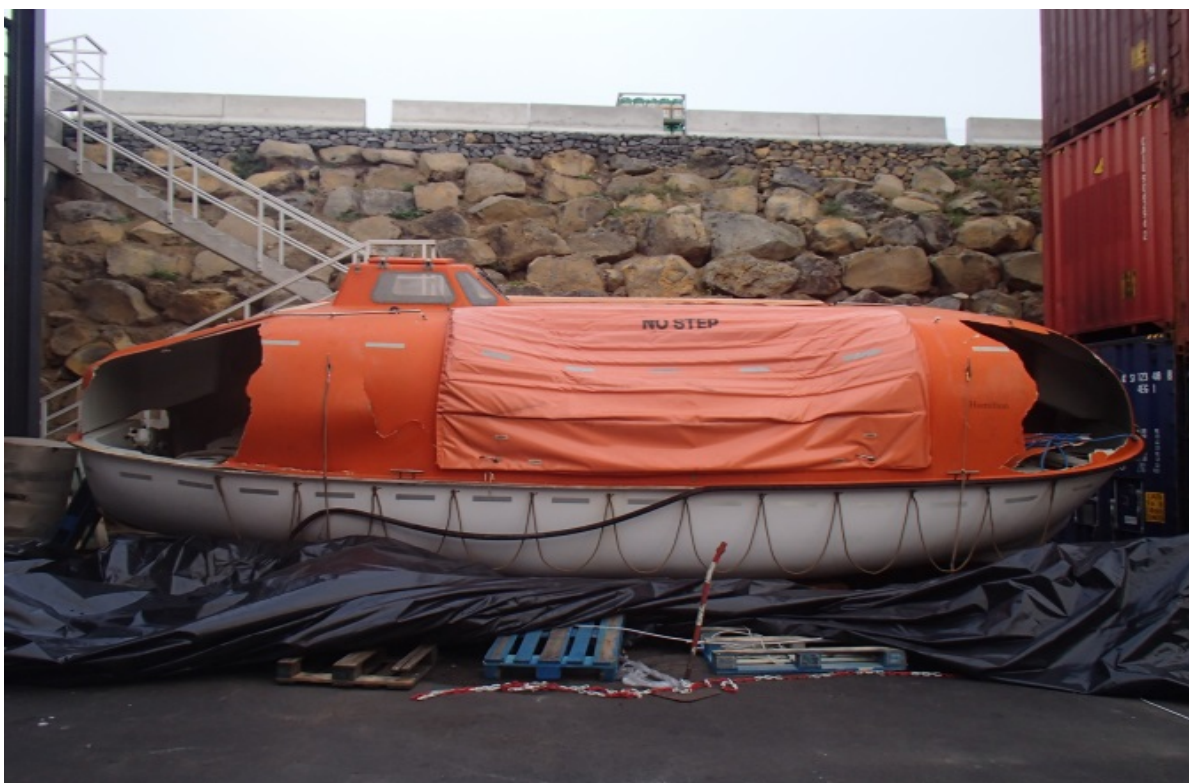
**Figure 10:** Lifeboat No. 5 Starboard Side Damage

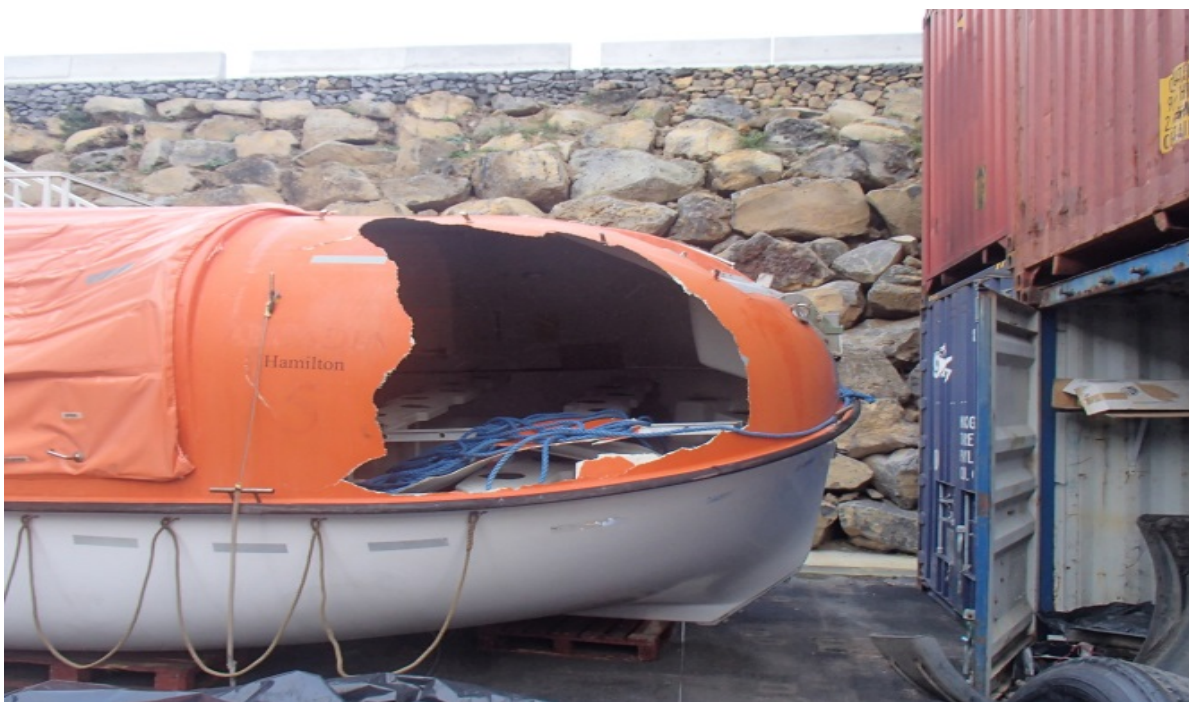
**Figure 11:** Lifeboat No. 5 Starboard Side Bow Damage

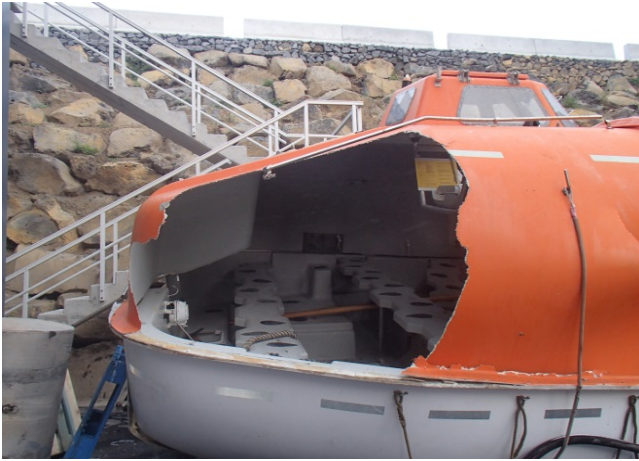
**Figure 12:** Lifeboat No. 5 Stern Damage

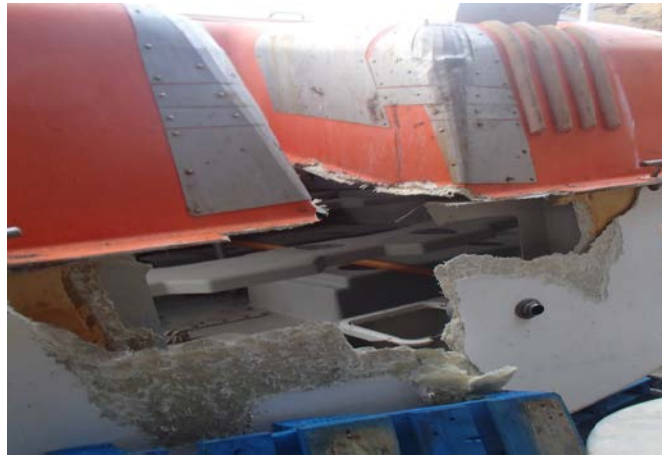
**Figure 13:** Lifeboat No. 5 Stern Damage – Note absence of aft hook
