Report on the investigation of

the fire onboard

Star Princess

**Report No 28/2006
October 2006**

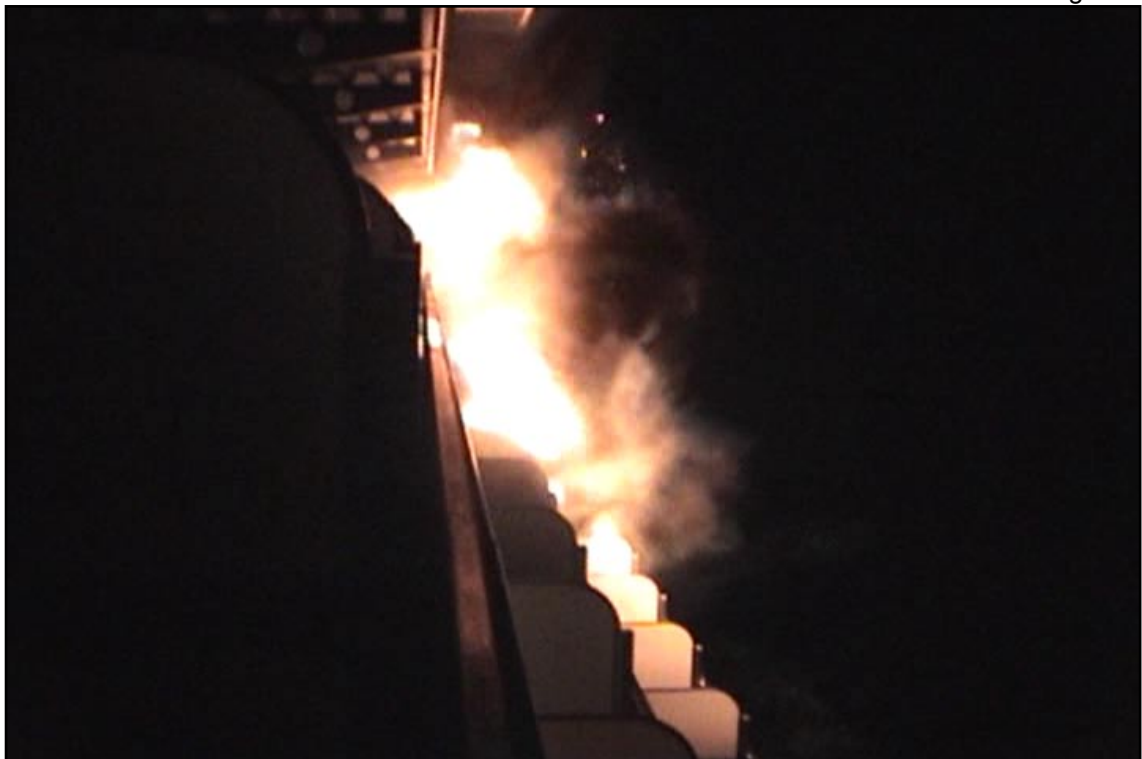
Figure 2

Still from video taken at 0311

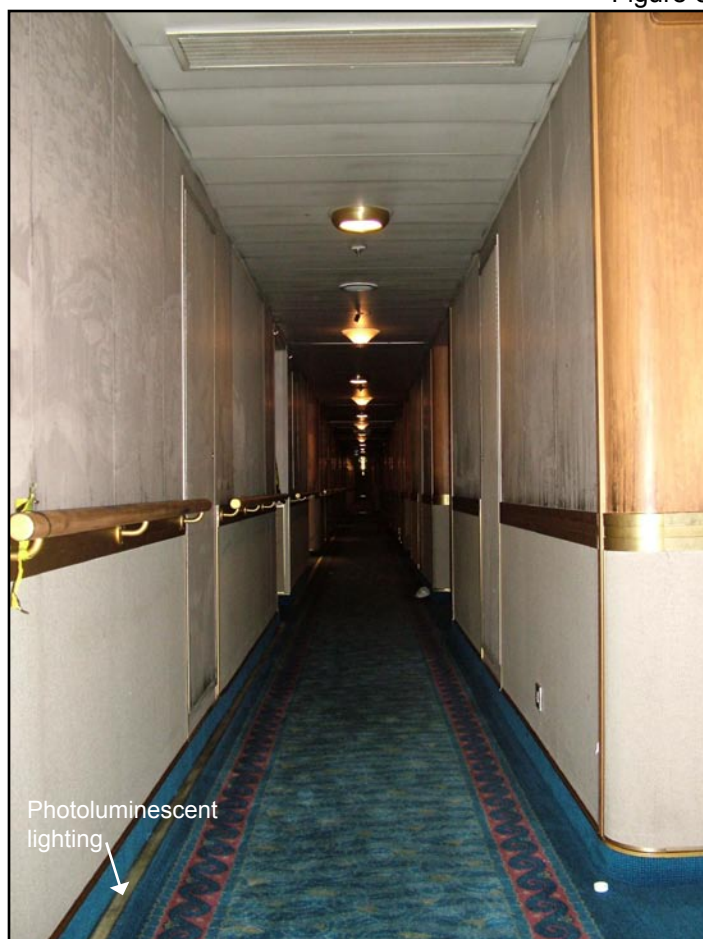
Figure 8

Alleyway in deck 12, zone 3

thick black smoke, combined with the water mist, made it very difficult to see more than 0.5m ahead. Movement was achieved mainly by touch; the PL lighting fitted to the deck was not seen. The firefighters opened the doors on both sides of the alleyway using master keys, and checked that they were empty. When the firefighters were about 15m along the alleyway, a semi-conscious male was found lying face up. The man was pulled to safety, and a stretcher party was called for. He was later identified as the male occupant of A320.

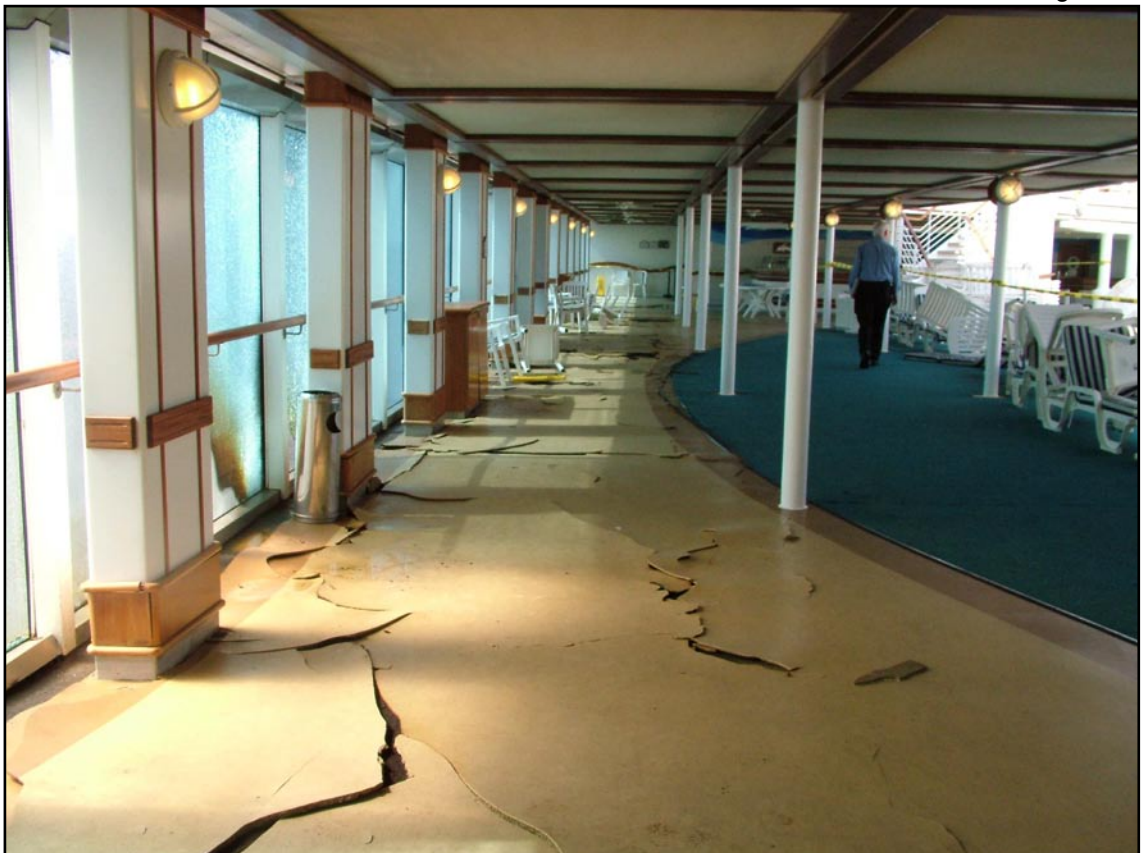
Figure 11

Damage to deck 14

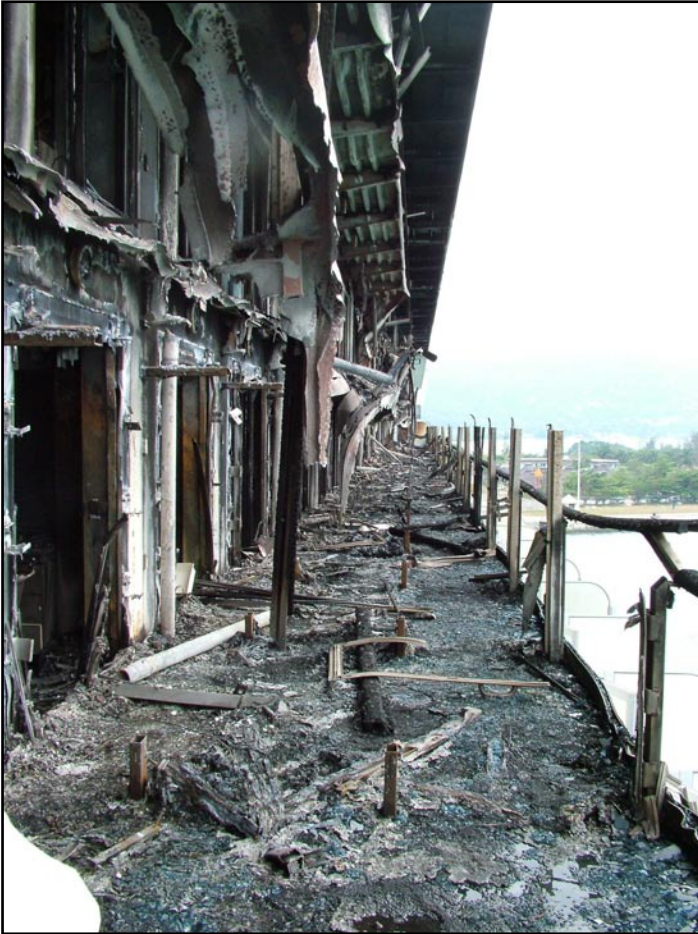
Figure 12

The fire generated sufficient heat to melt the aluminium structure of decks 11 and 12 (**Figure 12**). The heat also caused glass in the balcony balustrades and doors to shatter, which allowed the fire to penetrate into the outside staterooms (**Figure 13**).

Melted aluminium structure

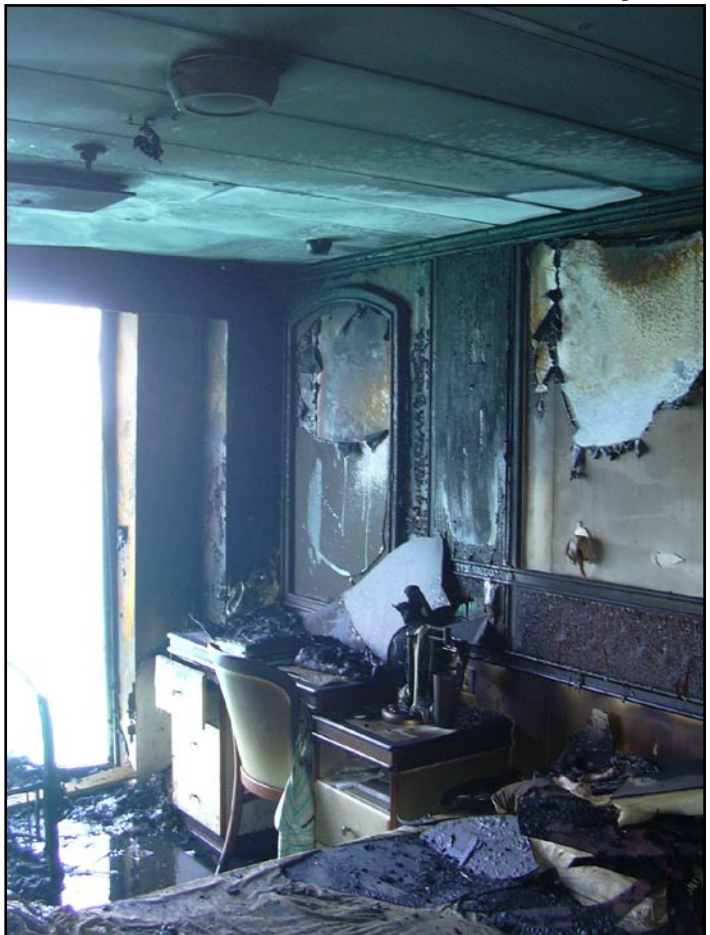
Figure 13

Damage to stateroom

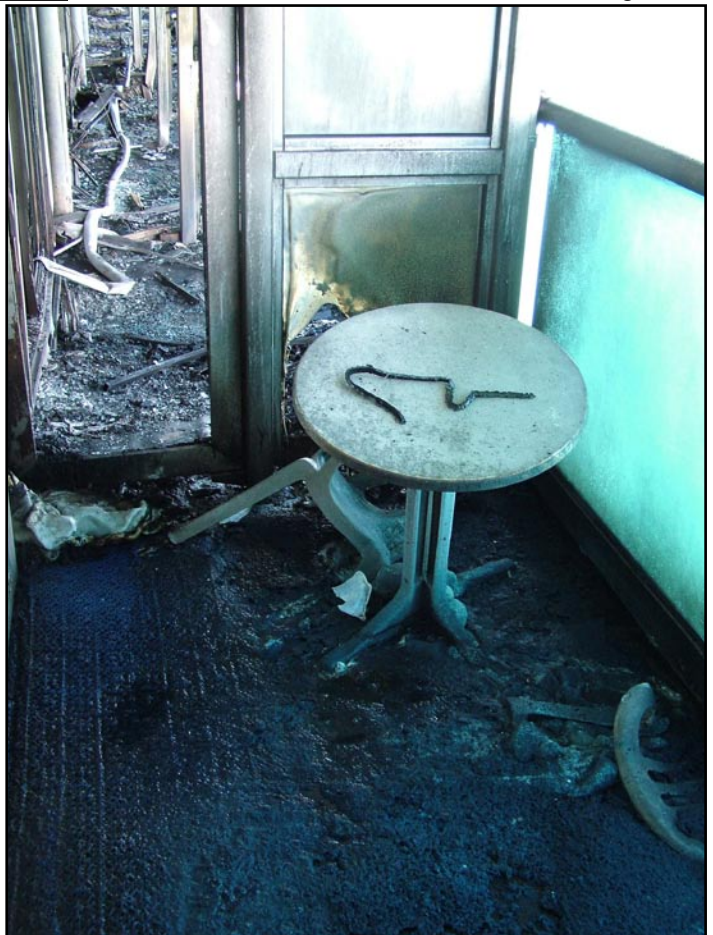
Figure 15

Partially melted balcony furniture

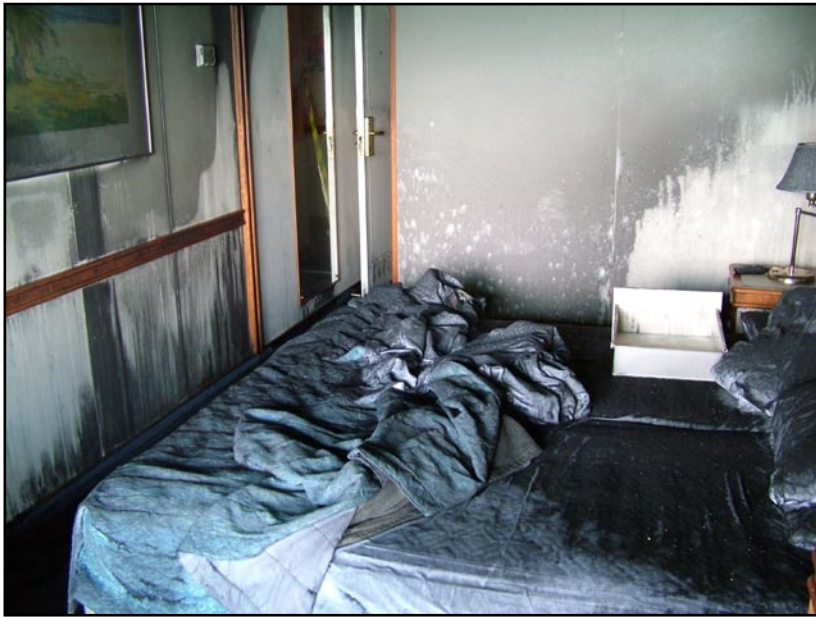
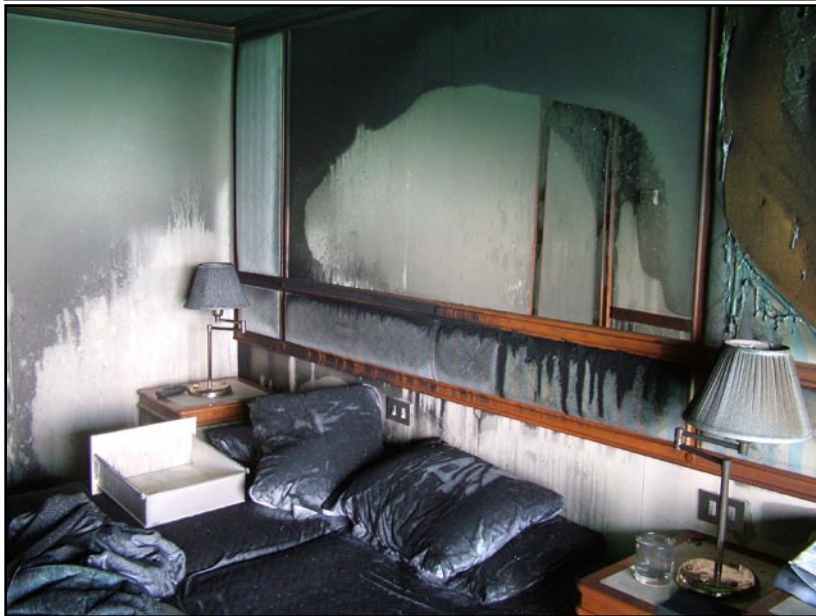
Fire damage in the staterooms was worst immediately inside their balcony doors, and reduced towards their interior. A rapid reduction in temperature was shown by undamaged chocolates found on many bedside tables, and bedding and furnishings, which looked charred (**Figures 16 and 17**), but were in many cases only stained with heavy soot washed from the smoke by the water mist.

Figure 16 and 17
Soot in stateroom interior

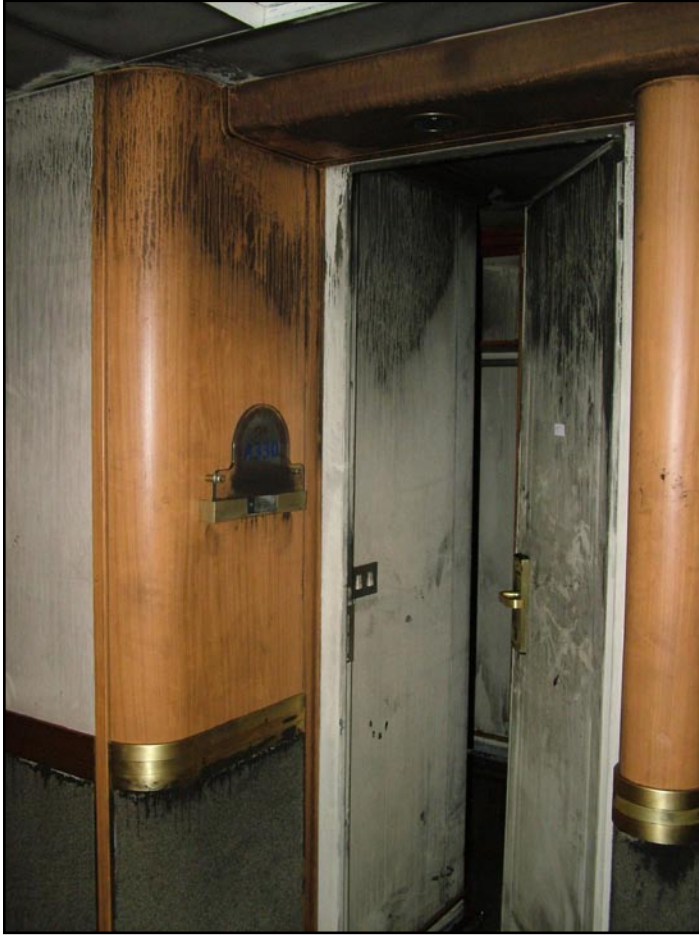
Figure 19

Soot deposits indicated that smoke entered the ship and reached internal alleyways in accommodation spaces through staterooms via open balcony doors. **Figures 19 and 20** show the soot deposits outside the entrance to staterooms of A330 and A338. The stateroom door of the latter was held open due to the insertion of a wedge in its self-closing mechanism. Although soot stains were evident in zone 3 on deck 12, they were less evident in zone 4 (**Figure 21**).

Door to A330

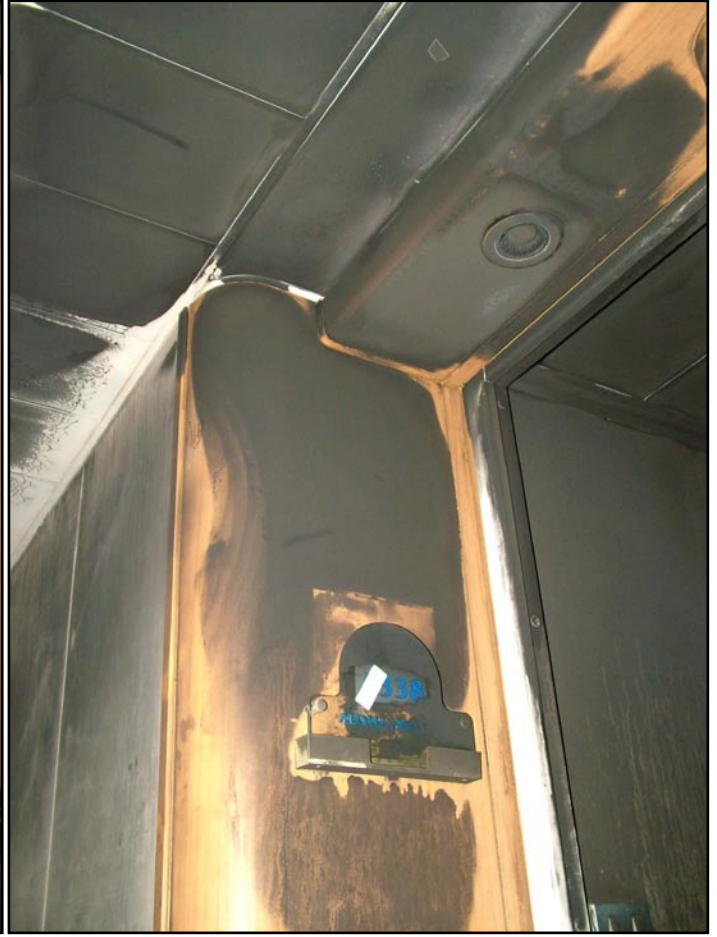
Figure 20

Door to A338

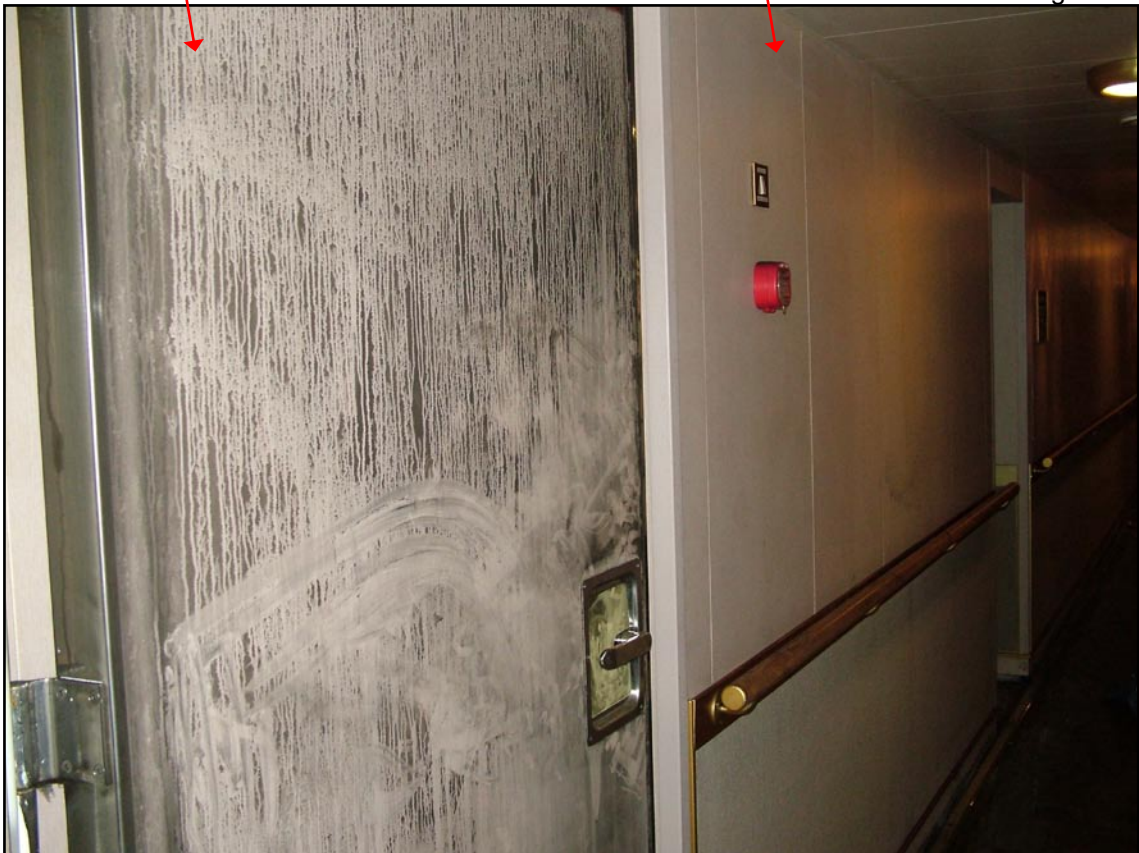
Figure 21

'A' class fire door between zones 3 and 4 on deck 12, port side
