This is an investigation report issued by the Bermuda Department of Maritime Administration (DMA), into a fire on the cruise ship Royal Princess off Port Said, Egypt on 18 June 2009. The DMA conducted the investigation pursuant to the IMO Code for the Investigation of Marine Casualties and Incidents (Resolution A.849(20)).

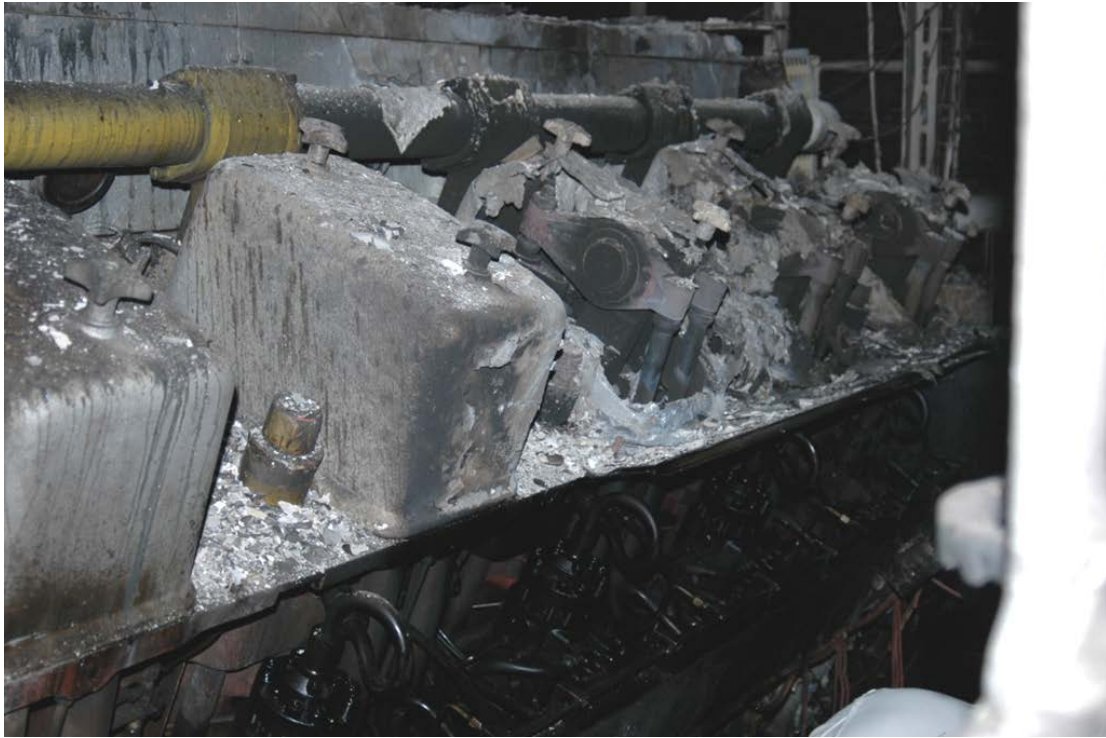
- 5.4.1 It is clear from the physical evidence that the main seat of the fire was at the forward end of main engine No.4 on the inboard side. In this area the engine is severely damaged; the aluminium crankcase doors and the cam shaft doors have melted away for units 1, 2 and 3 and wiring and other materials in this area are extensively damaged. On top of the engine the rocker covers for units 1, 2 and 3 have also been melted. The damage decreases further aft on the engine and the aft end is almost undamaged suggesting that the heart of the fire was at the forward end.

- 5.4.3 Looking at the area on the inboard forward side of the engine which was the seat of the larger fire there is evidence that suggests fuel leaking down the side of the engine and of fire then burning up from the base of the engine to melt the crankcase doors and the rocker covers. Inside the hot box there is some blackening but little sign of serious fire suggesting that although there may have been some fire inside the hot box, it was small compared to the ferocity of the fire outside the box. The electrical wires adjacent to the failed flange, for example, remained intact<sup>3</sup>. The hot box cover was only slightly damaged suggesting an external fire with flames rising upwards from below the hot box affecting the side of the engine and the rocker covers but not a fire in the hot box itself.

*Engine No. 4 post fire looking forward on the inboard side towards the seat of the main fire. The hot box cover has been removed in this view and it is possible to see the fuel piping and the injector pumps for each unit.*

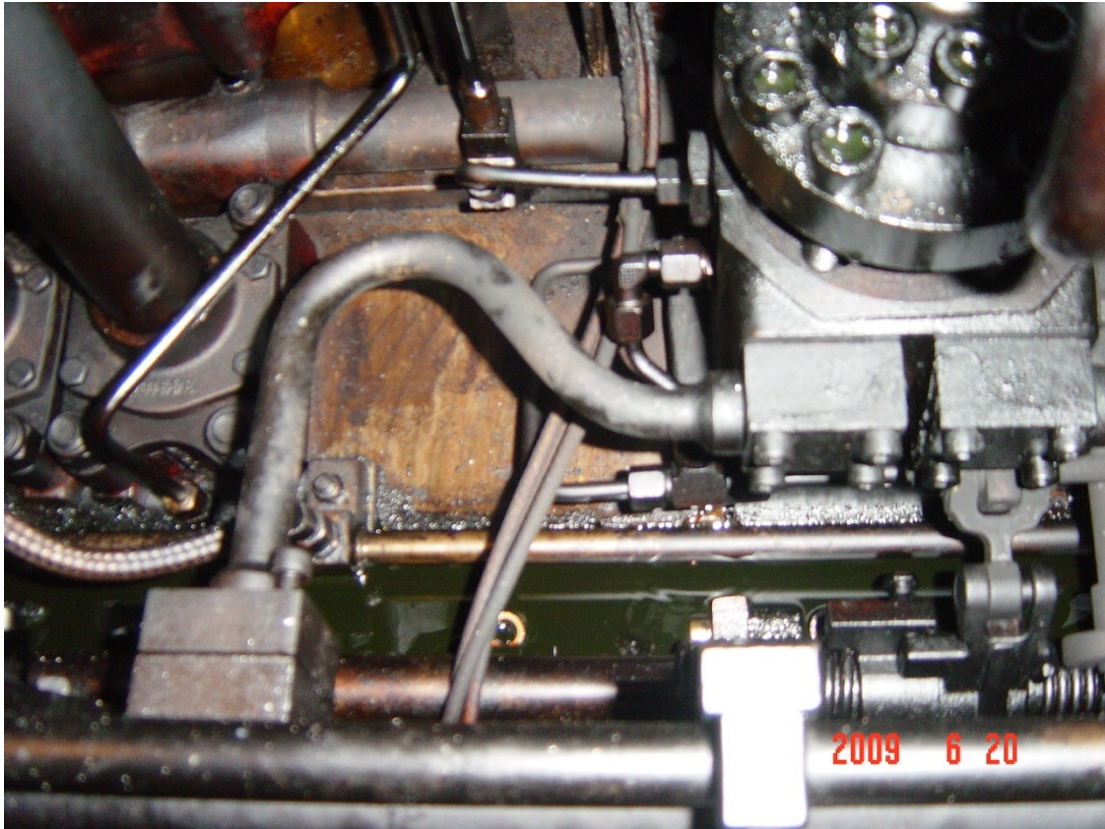
- 5.4.4 Looking in the hot box there is one connecting flange (between the return fuel pipe from injector pump No.2 to the fuel return line) that is loose. These flanges are normally secured with four bolts and an “O” ring seal. Examining this unit after the fire there was only one bolt in place and that bolt was loose. Two of the other bolts were found intact in the bottom of the hot box. The third bolt had not been recovered at the time of the investigation. This 18mm pipe normally carries unused hot fuel at about 7 bars from the injector pump to the fuel oil return line.

*The flange on the return fuel line from injector pump A2 on Engine No. 4 The nearest bolt is loose and protruding; the others (one for each corner) are missing. The flange is open 1 to 2 mm.*

- 5.4.10 It is also the case that although the personnel doing this job have never found a loose bolt to their knowledge, the normal operation of a torque wrench is such that a bolt might be very slightly loose but remain undetected by a torque wrench user as the normal operation of a torque wrench requires some turning effect until it clicks against the torque setting. It remains very possible that many of the bolts tend to loosen very slightly over time but the regular scheduled torque checks re-set them. However the bolts in a missed flange would continue to loosen until the next inspection or until failure.
- 5.4.11 As well as the 3 monthly checks there is a scheduled visual inspection and clean for the hot box every 150 running hours. Such an inspection would not reveal loose bolts unless they were grossly loose.

- 5.4.12 It remains unclear how or why the four bolts on this pipe came loose. There is no clear evidence to suggest that they were loose in April when they were inspected and none of the other ones were found to be loose. The April inspection concentrated on checking tightness and did not involve loosening any bolts. There are several possible causes ranging from unusual harmonic vibrations for the fuel injector pump to some metallurgical or manufacturing fault in the bolts themselves. Alternatively the possibility that this particular flange was missed out during the April check cannot be ruled out. The staff concerned have no recollection of doing so but they do not recall ever having found a loose bolt while doing this inspection. However it remains possible that, with the need to check over 250 bolts against a time limit in a scenario where the people involved have never knowingly encountered a loose one, one flange out of 24 identical ones could be easily missed, especially if this one was at about break time. It is entirely possible that the two men could resume on the next but one flange. Visually there is nothing to indicate that the bolts have been checked and the tight fit of the flange in situ with its “O” ring would very possibly not immediately show a leak when pressure was restored.

- 5.4.19 **It is concluded that the reason for the fuel line return flange bolts becoming loose cannot be determined with certainty at this stage but of the possibilities that exist, it is concluded that the most likely explanation is that the routine torque setting check on fuel system bolts in April missed this flange and the bolts, already slightly loose, loosened further in the interval.**

- 5.4.20 **It is recommended that the manufacturers Wärtsilä are consulted with a view to analysing the cause from their experience and formulating any changes necessary to prevent a recurrence.**

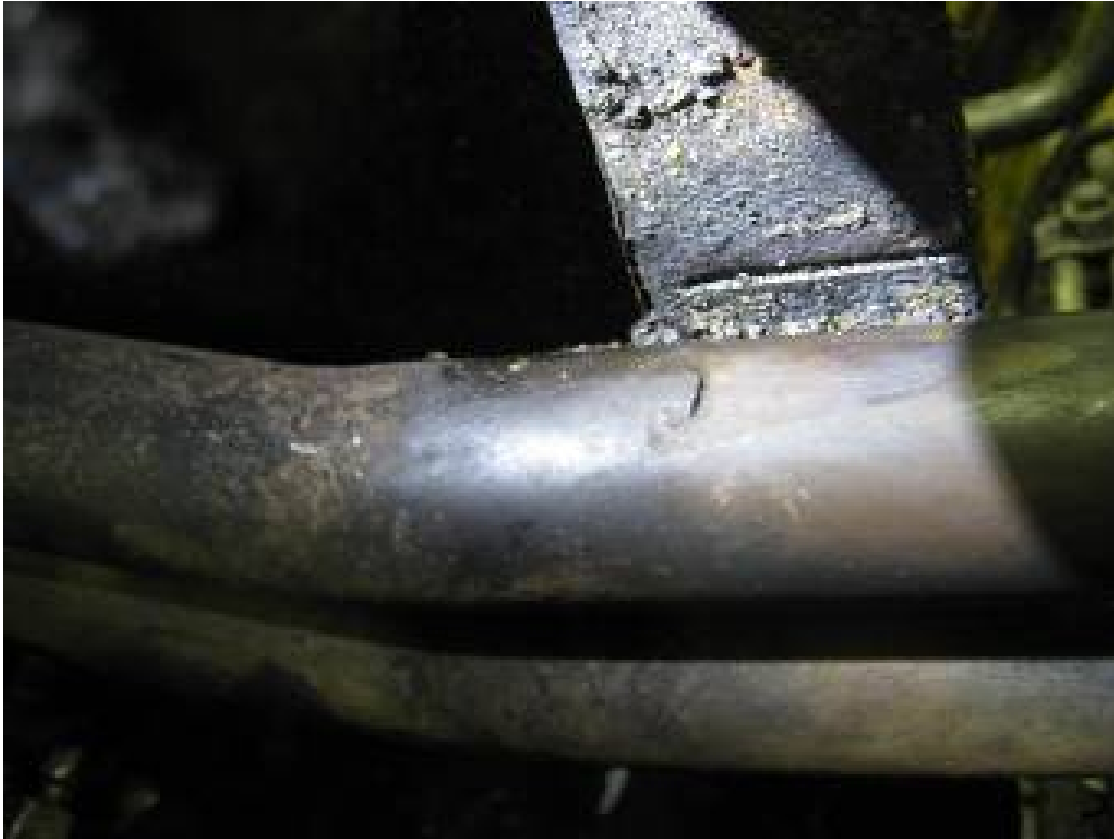
- 5.4.13 As well as running down the length of the hot box, the fuel feed and return lines cross over from one side of the engine to the other. The crossover link is situated at the turbo charger end and runs up from the hot box on each side then transversely across the engine before running down to the opposite hot box. The pipes are protected by bolted on covers to the point where they enter the hot boxes on each side. The subsequent opening up of the engine during repairs revealed that the fuel line on the inboard side of No. 4 engine where it enters the hot box had a small split approximately 1 cm in length aligned across the pipe.

- 5.4.14 Looking at the area it is clear that this split was caused by the edge of the steel cover coming into contact with the pipe and then vibration between the cover and the pipe wearing through the pipe. A bolt that should have held the cover in position was missing allowing it to make contact with the pipe. Fuel leaking or spraying from this split would have both entered the hot box through the space where the pipe enters and would have emerged from around the pipe cover to the area around the aft end of the engine.

*View of the fuel line split at the point where the line enters the hot box at the aft (turbo charger) end of engine No. 4*

- 5.4.18 **It is concluded that during the last occasion when the pipe cover was removed, the bolts securing it in position were not all replaced, or were replaced insufficiently tightly so that they subsequently vibrated loose, allowing the cover to drop into contact with the fuel pipe.**

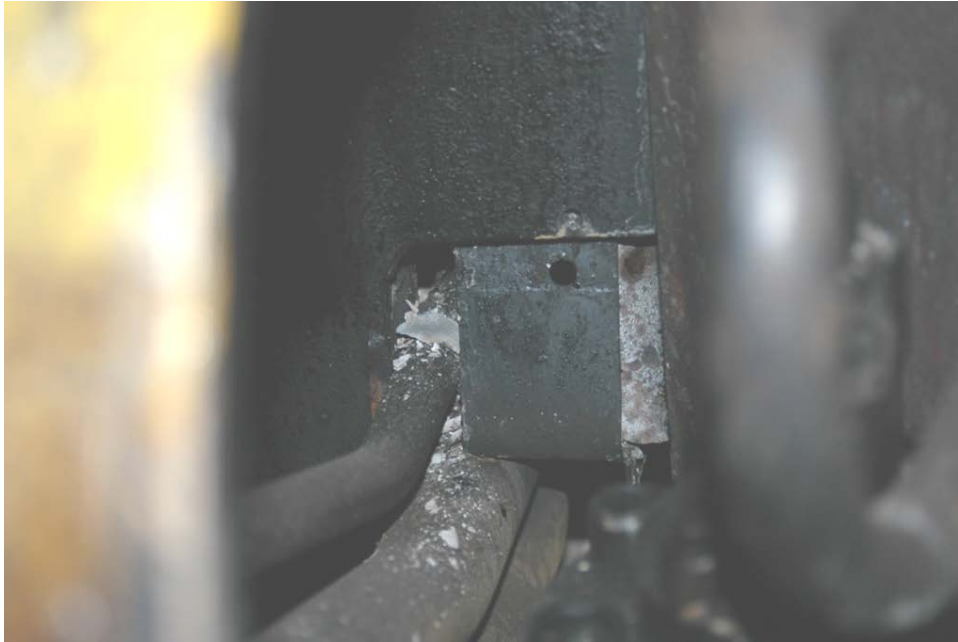
- 5.4.28 An examination of the hot box shows that it is not tightly sealed and that at each end there is an opening leading upwards to the cylinder top. These two openings are in the form of slots about 20 cm high and about 5 cm wide. At the aft end of the engine the lower part of the slot is blocked by emerging pipes leading to the fuel cross-over.

*The opening at the aft end of the hot box on engine No. 4 partially blocked by pipes passing through. This is looking inwards towards the cylinder heads. Note the missing bolt on the cover and the cover dropped down to lie against the fuel pipe.*

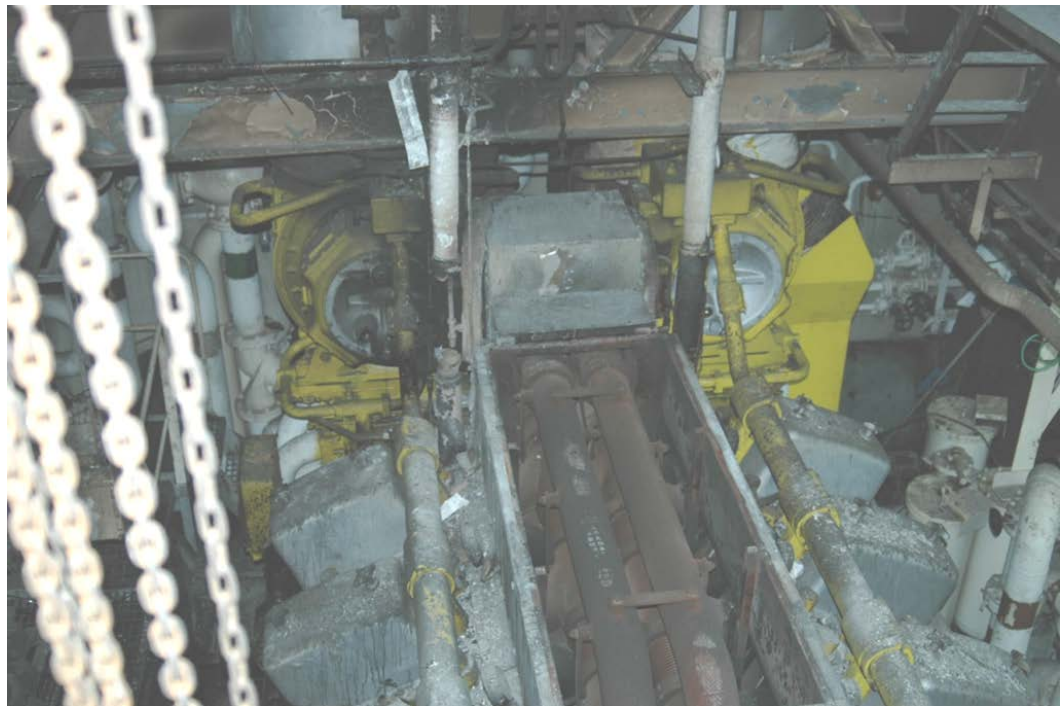
- Ample air was being supplied via the ventilation supply trunks adjacent to this part of the engine. This fire burned upwards on the end and forward side of the engine creating the damage visible post fire. This fire created large volumes of smoke and hot gases that drove the assessment party out and as it was drawn into the turbo charger on the running engine the sudden huge increase in black smoke from the funnel was observed by the Doctor after the staff engineer had left.
- When the fuel oil supply was eventually cut off before CO<sub>2</sub> injection the remaining fuel in the hot box drained away through the leakage drains to the collection tank and through the cable grommets leaving the hot box as it appeared post fire; oily but without significant fuel content.

*Engine No. 4 looking aft with the exhaust header covers removed. The seat of the initial fire can be seen in the scorching evident on the inboard side of the engine at the turbo charger close to where the cross over fuel lines enter the inboard hot box with evidence of scorching on the beam above.*

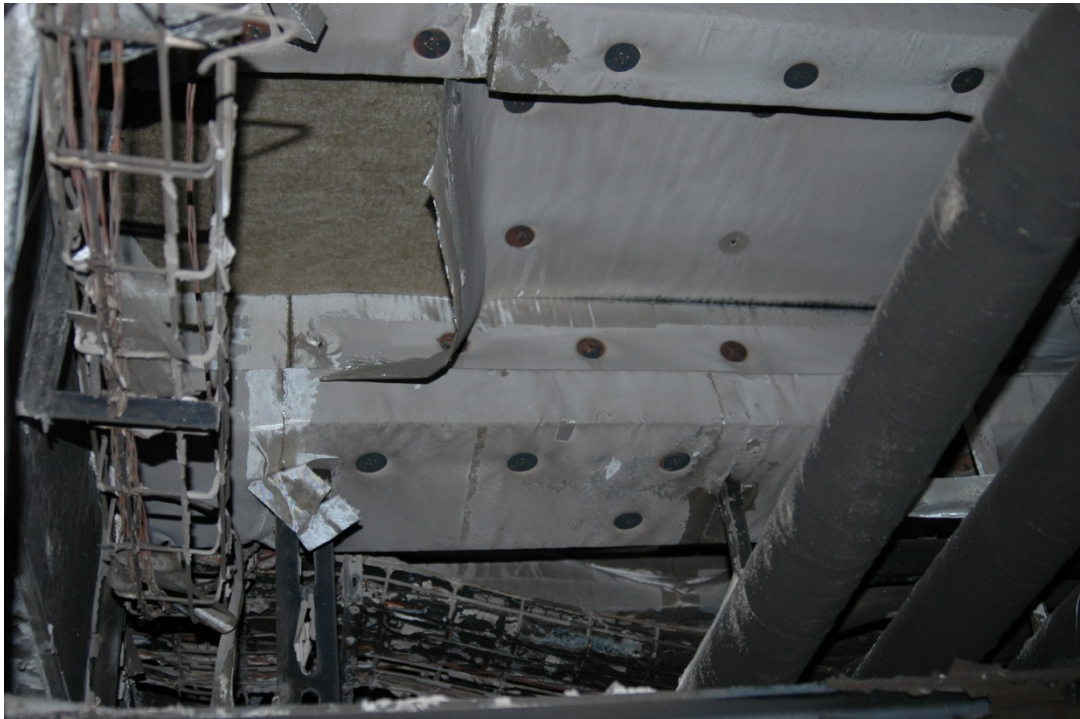
- 5.8.1 The engine room deckhead is required to be an A60 standard over much of its area in view of the designation of the spaces above. Following the fire it was clear that the insulation remained in place. During the fire there were reports of smoke from the scupper drain in the CO<sub>2</sub> release locker. This feature was identified in the engine room and is located almost directly over the seat of the fire. It is well covered by appropriate insulation and the outlet pipe has an insulation ribband as required. The smoke observed was probably from dirt and water collected in the bottom of the scupper which would invariably become hot.

*View of the engine room deckhead above the fire showing fire insulation intact and secured with only minor damage to covering material. Note cable trays with the cables completely burnt away.*

- 5.8.3 **It is concluded that the ship's structural fire protection was fitted as required by regulations and performed as designed. There is no evidence that the level of heat transmission through any of the protected bulkheads exceeded what might be expected from a good A60 boundary.**
