**BERMUDA MERCHANT SHIPPING INFORMATION NOTICE**

**Direct Opening from Cargo and Machinery Spaces into Sleeping Rooms**

Notice to all Ships and Vessel Owners, Ship Operators and Managers; Masters and Officers of Bermuda Registered ships

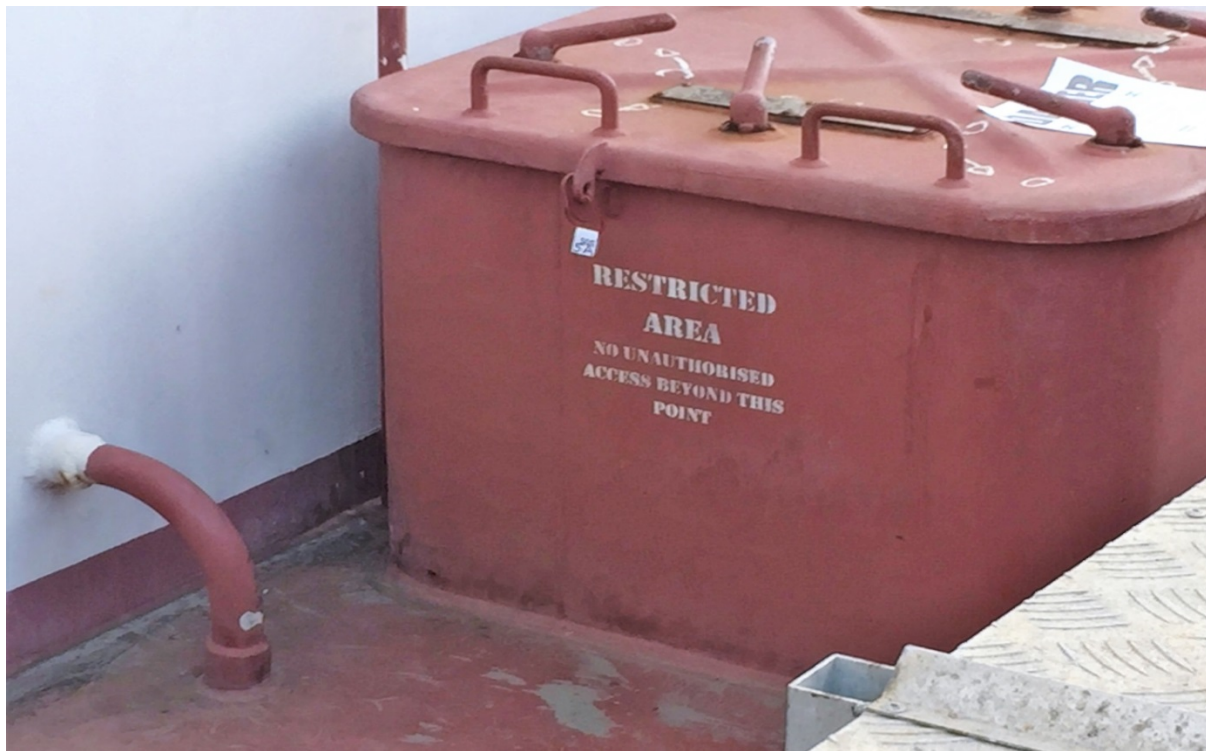
The above mentioned fatality was caused by asphyxiant gas used as a cargo fumigant leaking into a crew member's cabin through an inadequately sealed cable duct running from the cargo hold to behind the cabin bulkhead lining.

The Bermuda Administration is concerned that such openings may be behind bulkhead linings and penetrations are not sealed adequately.

1. Ship Owners, Managers and operators should consider implementing a more vigorous inspection of the bulkhead penetrations to ensure that there can be no possibility of leakage from cargo to other spaces, including at the build stage and during subsequent installations.
2. Masters, Chief Engineers and Senior Management on board ships should be actively involved in locating and monitoring any penetration, especially at dry dock when new equipment may be fitted and systems may be modified. Ship owners, managers, operator, masters and chief engineers are to ensure that Class and Statutory Surveys are conducted in a timely manner and any defects identified are rectified promptly;
