BERMUDA MERCHANT SHIPPING INFORMATION NOTICE

Notification of Damage to LNG Cargo Tanks Due to Failed Cable Tray in Cargo Tank No. 1

Notice to all Vessel Owners, Ship Operators and Managers, Masters and Officers of Type 2G Bermuda Registered LNG Carriers

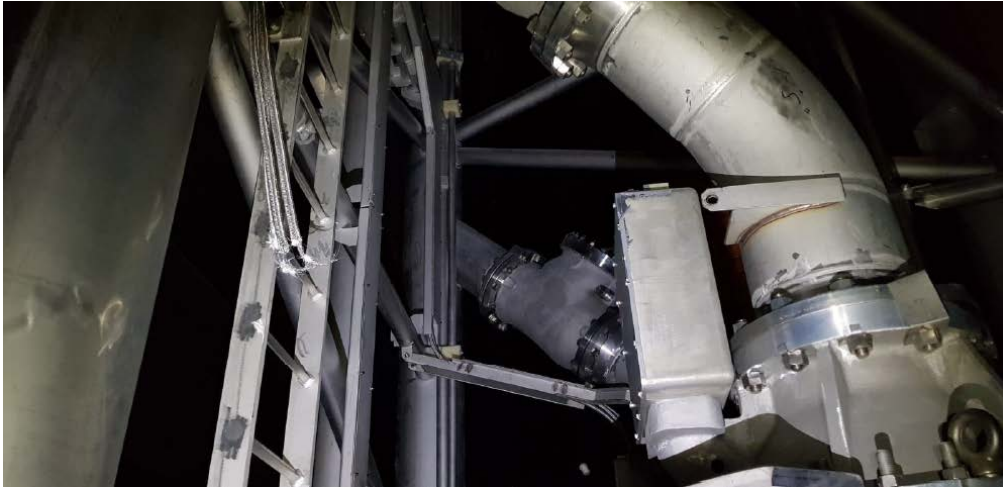
This Bermuda Merchant Shipping Information Note (“BMIN”) is issued following the same type of incident occurring on two different Bermuda registered type 2G Membrane Tank LNG carriers. In both cases parts of a cable tray leading to the cargo pump had fallen from the upper support level into the tank when it was loaded with cargo. Due to sloshing effects the cable tray then moved extensively within the tank and caused multiple perforations of the primary membrane/barrier. These incidents both lead to an unplanned dry docking to complete the necessary repairs.

- Movement of cable tray caused by sloshing effects and pump tower vibration, particularly during cargo operations
- In one instance the cable tray cover bolts were not tack welded and in the other the tack welds on the cable tray lower support bolts failed
- In both cases the bolts loosened over time due to vibration and sloshing effects
- In the first instance the cable tray cover fell into the tank once the bolts came loose
- In the second instance the cable tray was hanging on the welded upper supports only, which eventually failed through fatigue under cargo sloshing effects

Fig. 1: Location of fallen cable tray

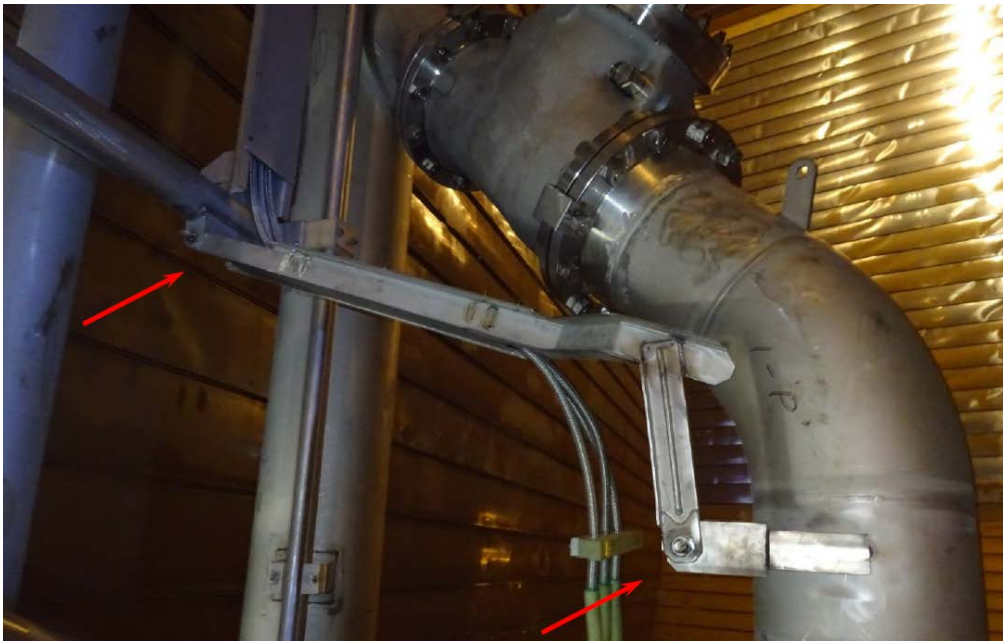
Fig. 2: Cable tray following repair
