**BERMUDA**

**Department of Maritime Administration  
Ministry of Tourism Development and Transport  
Government of Bermuda**

**INVESTIGATION INTO A MISSING CREW MEMBER  
FROM PASSENGER SHIP "QUEEN MARY 2"  
ON 15TH AUGUST 2015**

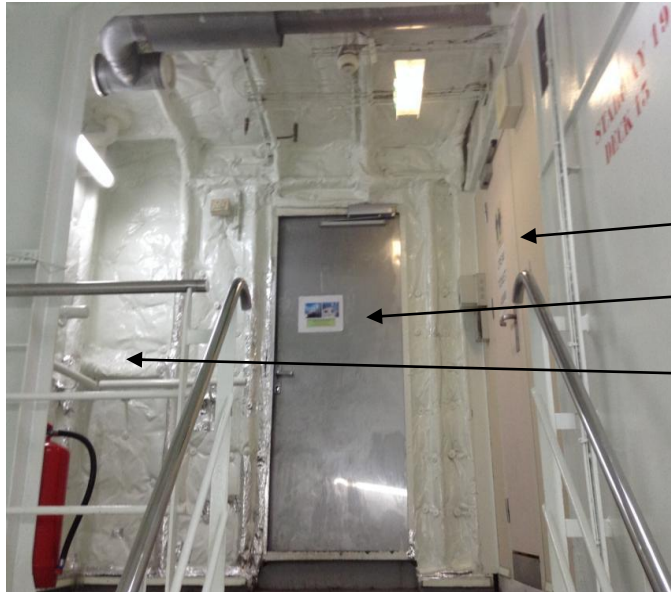
### Stairway 19 – Deck 13

Unisex toilet

Door to open Deck – crew area

Recess where couple was standing.

After a period of time out on deck, estimated to be around 30 minutes, witnesses report seeing Mr. Ordenes and his male companion entered the unisex toilet at the same time, and closing the door behind them. They both came out of the toilet after about 5 minutes and proceeded to the open deck area. Once they were outside on the deck, they joined the third crewmember who was the female. This was all witnessed by the couple who were on the stairwell.

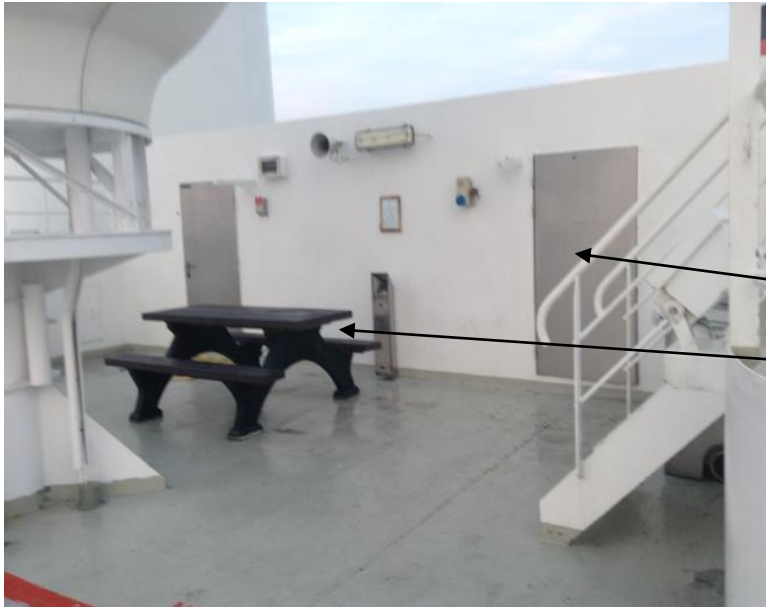
**Open Deck on Deck 13 –**  
Crew smoking area.

Door onto open Deck

Bench

Very shortly after they arrived back outside the accommodation, Mr. Ordenes started to roll around the deck, shouting and screaming and started crawling towards the ship's rail. The male crewmember, who is alleged to have been in the toilet with Mr. Ordenes did not take any notice of this dramatic change of demeanor, and remained seated at the table. The female member of the group shouted for help. This call for help was answered by the couple who were standing on the top platform inside the stairwell. Hearing the commotion they came out of the stairwell and onto the deck. They assisted in restraining Mr. Ordenes, and then kept him away from the ship's rails. Later, the couple from the stairwell and the female member of the group, moved Mr. Ordenes off the deck and back inside the ship.

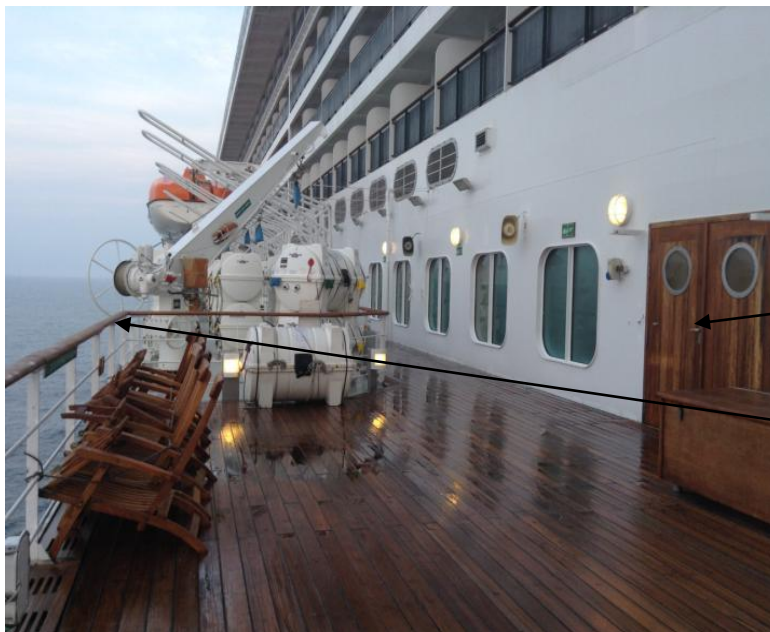
**Deck 7 - Promenade deck**  
View of door where Favio Ordenes exited onto the open deck.  
Railings position

Promenade Deck Port Side

At 0244 hrs Mr. Ordenes is observed to walk out of a lift, on stairway 19 at deck 7 level. As he came out of the lift he turned briefly towards the starboard side, before turning round and walking over to the port side. He turned aft and almost immediately port again. He walked through a door onto the Promenade deck and, as he walked across the open deck, he dropped his clothing onto a deck chair and climbed onto the ships side railing. This time is recorded on the CCTV as 0245. He remained in a position where he was crouched on top of the side railing, bent over facing outboard. He was gripping the top rail with his right hand while he used his left hand to steady himself. His left foot was on the top rail and his right foot on the inboard side of the middle rail. As he steadied himself he placed his left hand on the top rail. He remained in this pose for nearly two minutes, until 0247 when he let go of the rail, pitched forward over the top railing and let himself fall over the side of the ship.

The handrails on deck 7 are 33m above the sea. A person with a bodyweight of 80 kg falling this distance would impact the water in 2.60 seconds, with a speed of 25.43 m/s, and the consequences would be drastic.

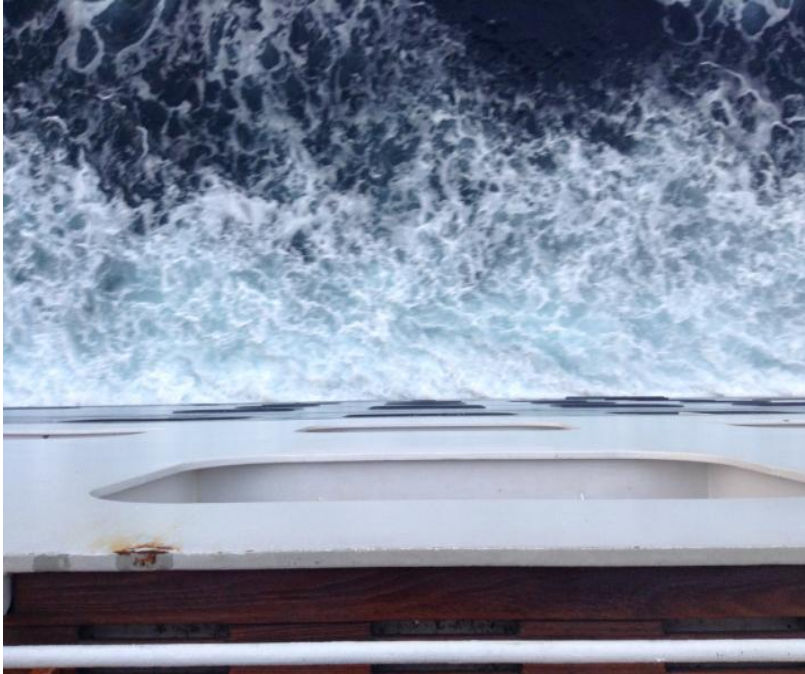
The view over the side of Queen Mary 2- from deck 7
