Report on the investigation of

the fire onboard

Star Princess

**Report No 28/2006
October 2006**

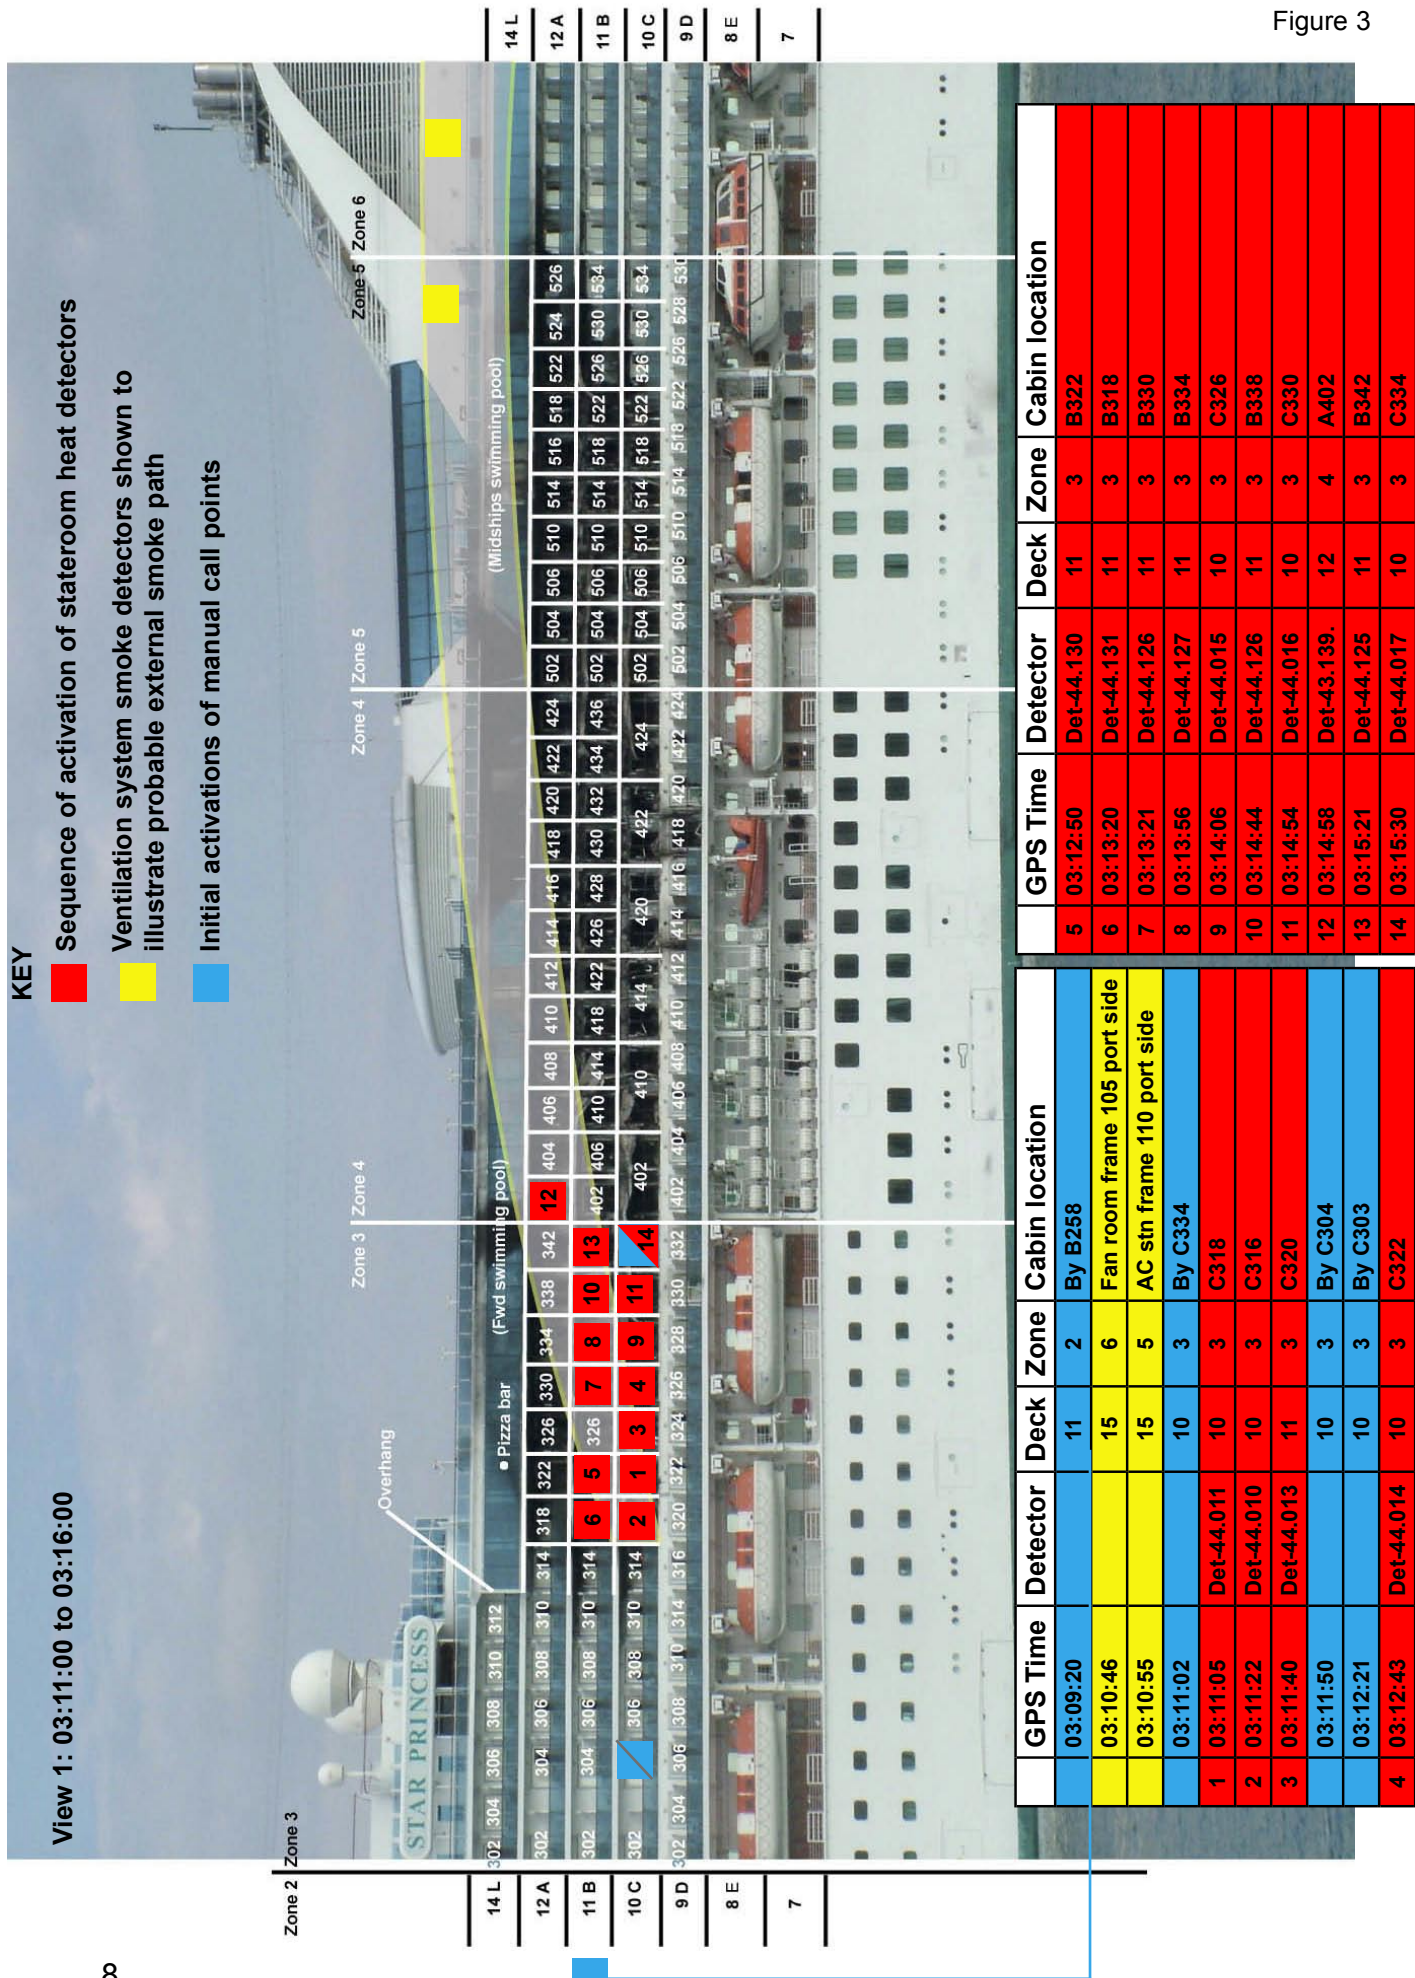
Figure 3

Figures 3 to 6 show the activation of smoke and heat alarms recorded on the vessel's fire detection system, and a chronology of significant events is at **Table 1** below:

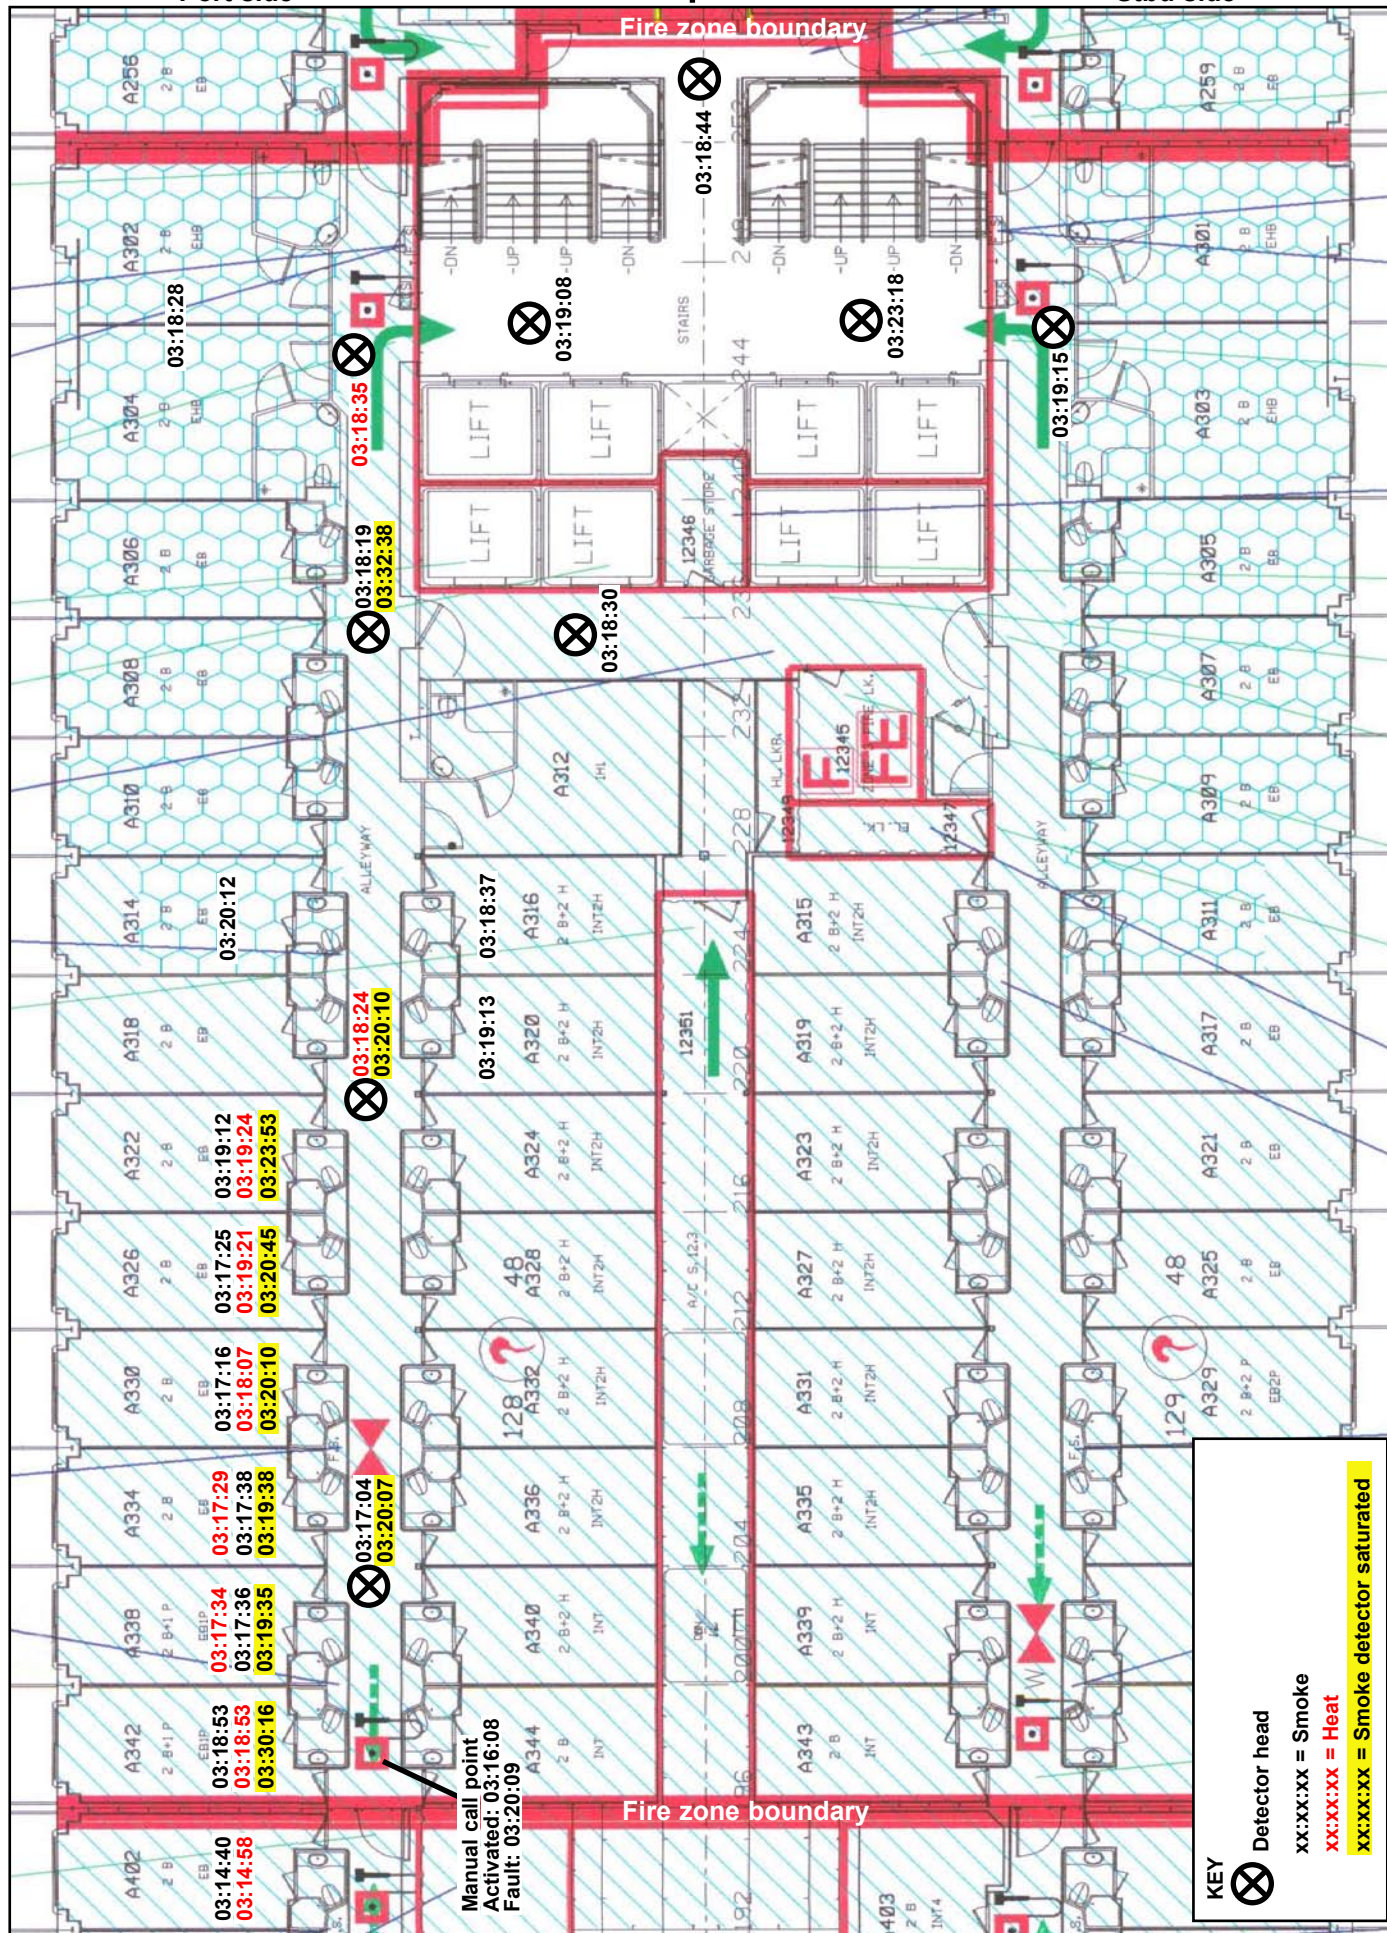
Figure 7

Following the arrival of the assessment party on deck 11, all of the staterooms were cleared of passengers in zones 3, 4, and 5. On deck 12, passengers who were not woken by noises on their balconies were woken by noise in the alleyway, banging on doors, the PA announcements from the bridge, and the signal for the crew to proceed to crew alert. None appear to have been alerted by the audible alarms fitted to the smoke and heat detectors fitted in each stateroom and in the alleyway. After hearing the crew alert signal, an elderly male passenger in A402 opened his balcony door and was overcome by thick black smoke. The door could not be closed, and the water mist head in the stateroom was activated. The smoke detector fitted in the stateroom activated at 0314.40. The passenger and his wife left the stateroom, but the male passenger collapsed when making his way to his muster station; he had suffered a respiratory arrest. The first manual call point to be activated on deck 12 was at 0316.08, which was located outside stateroom A342. An extract of the ship's fire plan, showing the port side of zone 3 on deck 12, and the recorded times of the smoke and heat detector alarms fitted, is at **Figure 7**.

Extract of fire control plan showing detection times on deck 12, zone 3

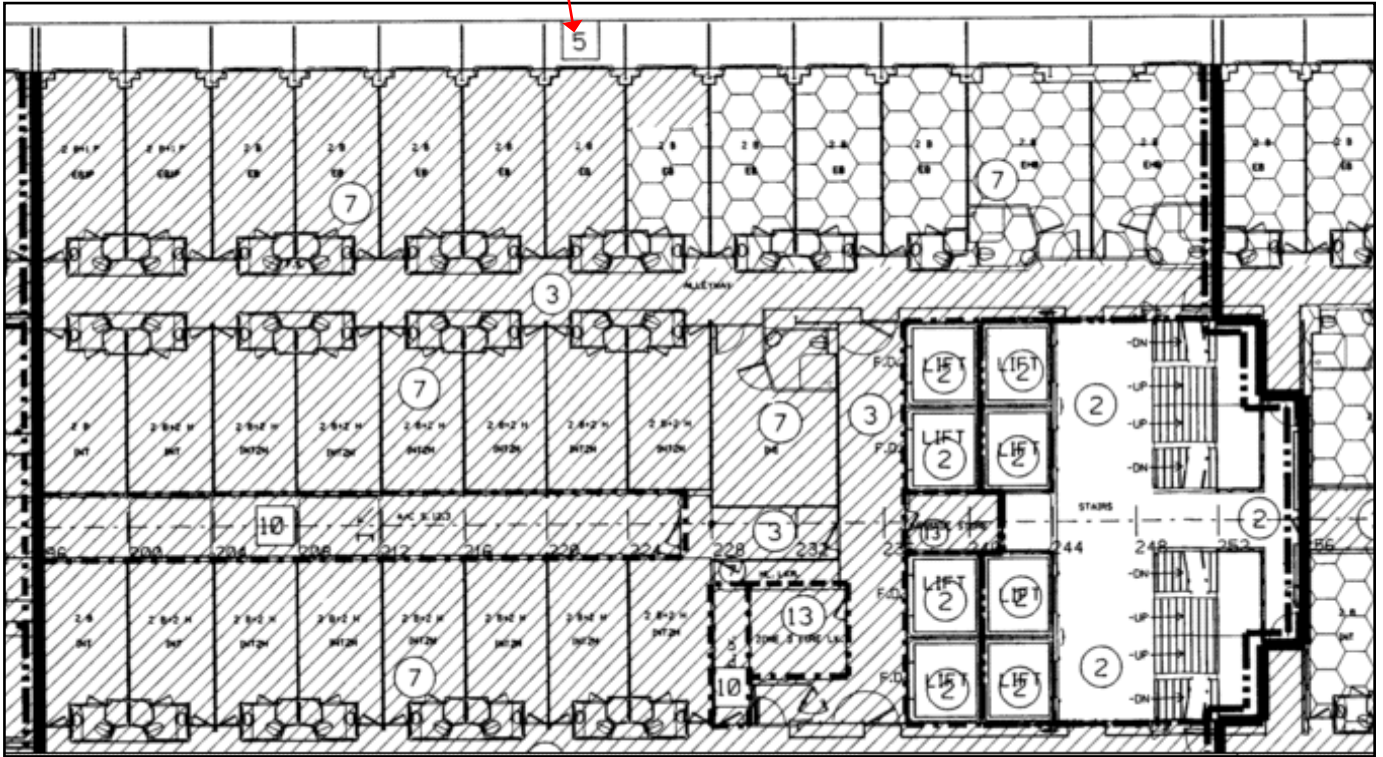
Figure 22

Star Princess has 15 decks and seven main vertical zones⁸ (**Figure 1**). A structural fire plan was provided by Fincantieri, which was approved by Lloyds Register of Shipping and RINA. An extract of the structural fire plan for deck 11 (**Figure 22**) shows that the external balconies were categorised as open deck spaces (category 5) which Paragraph 2.2.3.2 of Regulation 9 of SOLAS defines as:

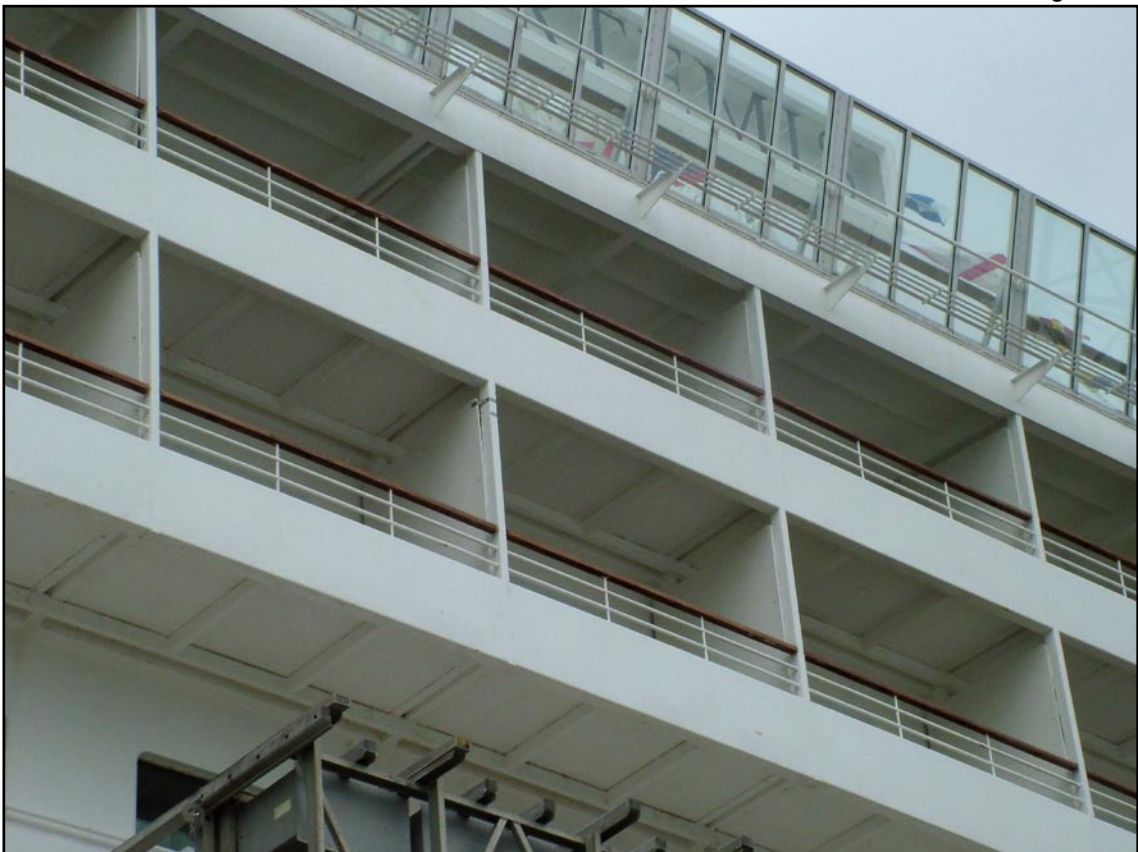
Figure 23

The first ship the MAIB is aware of to have been constructed with external balconies is *Royal Princess* (since renamed *Artemis*), which entered service in 1984 (**Figure 23**). The ship was built in Helsinki, Finland, and was UK registered. Review of the vessel's structural fire protection plan, which was approved by the MCA, indicates that the balconies were treated as open deck spaces, although this was not specifically annotated. The exemptions for doors and glass partitions and windows in 'A' class boundaries were noted on the plan. The balcony partitions on *Royal Princess* were made of GRP on a substantial steel frame, and the decks and furniture were both made of hardwood.

Balconies on board *Artemis* (ex *Royal Princess*)

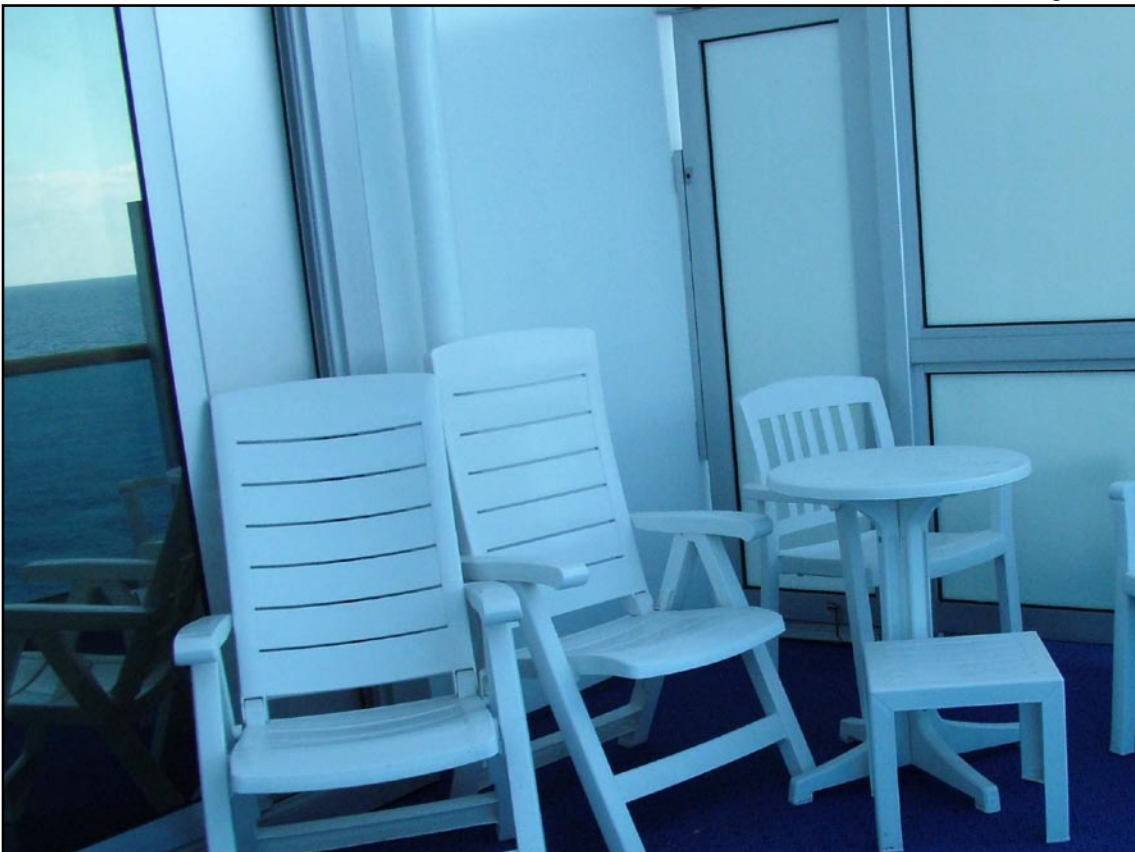
Figure 26

Balconies were separated by vertical partitions (**Figure 26**), which had small gaps at the deck and deckhead. The partitions provided privacy and shelter, and were fitted with a door, which could be locked by a universal square-ended 'T' bar shaped key. The partitions were constructed from 8mm polycarbonate sheet, secured in an aluminium framework. This was one of several types of material used by Fincantieri for balcony partitions, and *Star Princess* was one of 19 ships on which it had used the material. The materials the shipbuilder used on the balconies of other vessels included: acrylic, acrylic –polycarbonate mixtures, and aluminium composite. Materials known to be used for balcony partitions by other ship builders includes glass, steel, high pressure laminated boards, galvanised sheet, and plywood.

The decks of the balconies on board *Star Princess* were covered with a polypropylene tile (**Figure 26**). On decks 9 and 10, the tile was laid on top of a flexible screed coated with polyurethane self-levelling paint, but on decks 11 and 12 it was laid on top of a painted metal deck. Polypropylene tiles were laid on top of the deck coatings to provide a non slip finish and allow surface water to drain. This was one of three types of deck covering used by Fincantieri for this purpose, the others were teak, and a teak effect resin. A balustrade was fitted at the outboard edge, consisting of glass panels topped with a hardwood rail.

Balcony partitions, furniture and deck tiles

Lightweight plastic chairs, table and footstools (**Figure 26**) of the type commonly available for outdoor recreational use were provided for each balcony. The first heat detectors to activate were in staterooms C316 and C318, and items on the balcony of stateroom C316 at the time included two large cotton towels provided by the ship and draped over the plastic chairs, a bathing suit, and a pair of water shoes, all of which had been on the balcony for several hours. The passengers in C318 were smokers, and the last occasion a cigarette was smoked on the balcony was shortly after midnight. The cigarette end was then extinguished in an ashtray. The passengers in C316 were non-smokers, and were travelling companions of the passenger in C318. The door in the partition between the stateroom balconies was unlocked, but it is not certain whether it was open or closed.
