This is an investigation report issued by the Bermuda Department of Maritime Administration (DMA), into a fire on the cruise ship Royal Princess off Port Said, Egypt on 18 June 2009. The DMA conducted the investigation pursuant to the IMO Code for the Investigation of Marine Casualties and Incidents (Resolution A.849(20)).

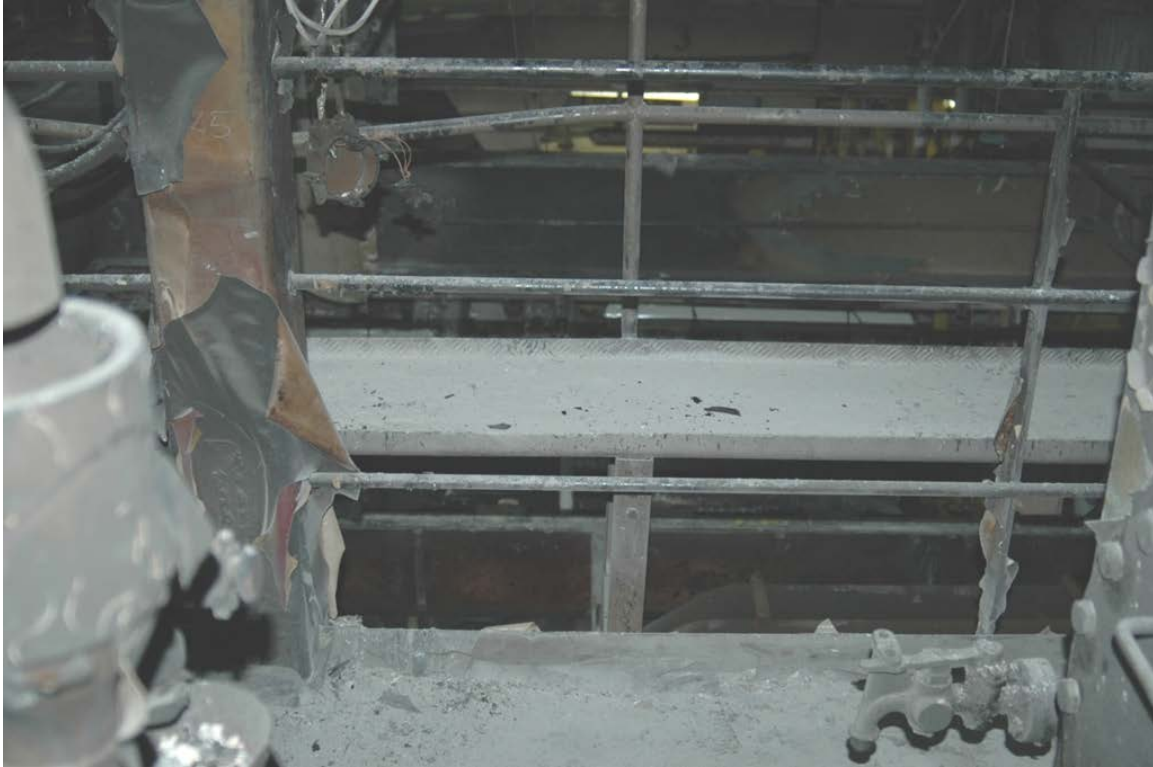
*Looking to starboard on deck 2. This is about the position from where the Staff Engineer and Senior First Engineer saw the fire when they entered. The turbochargers are to the right. In the gap between the deck edge and the first safety rail can be seen the top of No.4 engine.*
